CASE REPORT

A Shot Through the Window

REFERENCE: Burnett BR. A shot through the window. *J Forensic Sci* 2001;46(2):379-385.

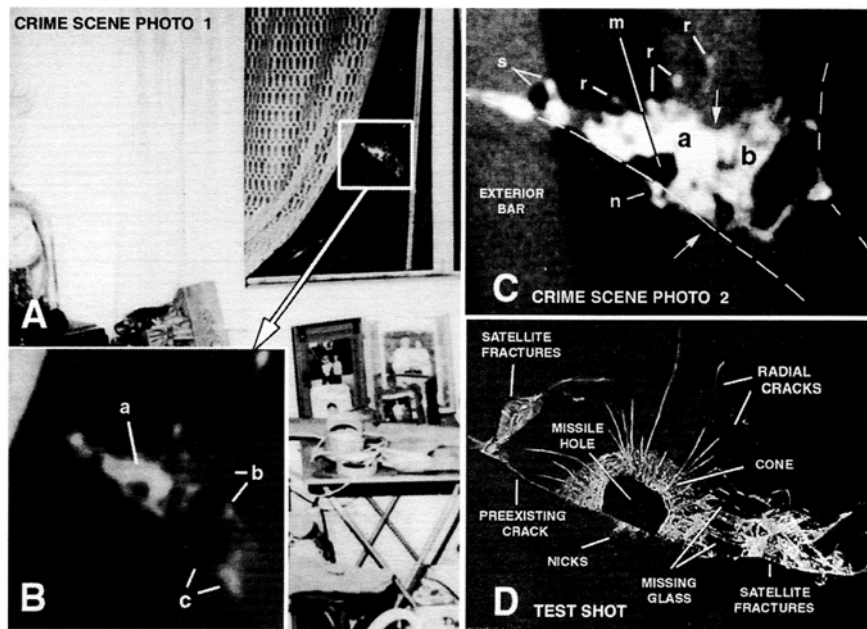
FIG. 1—A: One of the two crime scene photographs that show the questioned window defect. The thin bar to the right of the defect is part of the window screen frame. To the right of the screen frame is the center bar of the window. B: Enlargement of the defect in the window shown in A. (a) Region corresponding to the cone produced by a bullet. (b) Possible area of satellite fracturing. (c) Possible area of satellite fracturing that was apparently lost before the second photograph was taken. C: Enlargement of the crime scene window defect taken from the second of the two photographs that showed the defect. There was an outside decorative wooden grillwork approximately 12 in. (30 cm) from the window, two bars of which can be seen in the photograph. Dashed lines represent apparent preexisting cracks in the window. (a) Region corresponding to the cone produced by a bullet. (b) Possible area of satellite fracturing. "m" Apparent bullet hole. "n" Possible nicks. "r" Possible radial cracks. The arrows mark the border between regions (a) and (b). D: Image of one of the test shots through the previously cracked window. A small portion of the glass to the left of the bullet hole along the preexisting crack fell from the defect and was digitally reconstructed. The bullet hole in this defect is larger than those produced by the other test shots. This defect was selected because of the extensive satellite fracturing.

The other shots in this experiment series produced a defect on only one side of the window crack. The cone and radial cracks did not transmit to the glass on the other side of the crack, producing a "rising sun" defect (e.g., Fig. 1D). This feature was created when the bullet hit only or mostly (see below) on one side of the glass near the crack. This is the situation that appears to have occurred for the crime scene window defect, where the presumed .22 bullet struck mostly above a preexisting crack in the window. One of the test defects (Fig. 1D) closely resembles the crime scene window defect.

In the crime scene window, the area marked "a" (Figs. 1B and 1C) corresponds to the cone region in the test window defect (Fig. 1D) and the radial cracks correspond to apparent radial cracks ("r" in Fig. 1C) in the questioned window defect. In addition, there are small nicks in the test window defect (Fig. 1D) below the preexisting crack near the bullet strike hole. The crime scene window defect shows similar apparent nicks ("n" in Fig. 1C). Satellite fractures occur in several of the test shots (e.g., Fig. 1D). These areas are found a short distance from the cone and have extensive fracturing within a confined area. The area of the satellite fractures may

be relatively small (Fig. 1D, left) to fairly large (Fig. 1D, right). Some loss of glass may occur within the area of the satellite fractures at the time of the shot. It appears that in the crime scene window region "b" (Figs. 1B and 1C) is a satellite fracture area. There is likely an additional, smaller satellite fracture area to the left of the cone area ("s" in Fig. 1C).

The area of the questioned window corresponding to region "b" in the crime scene photograph (Fig. 1B) has a different appearance than that same region in the second crime scene photograph (Fig. 1C). The reason for the difference between the two photographs may be that depending on the camera and flash angle, satellite fractures reflect light back to the camera differently between photographs due to the angles of the fractures in the glass. A portion of the satellite fracture area in the lower right part of the first photograph of the crime scene window ("c" in Fig. 1B) does not appear in the second photograph of the crime scene window (Fig. 1C). Pieces of the defect likely fell from the window during the time between the two photographs.

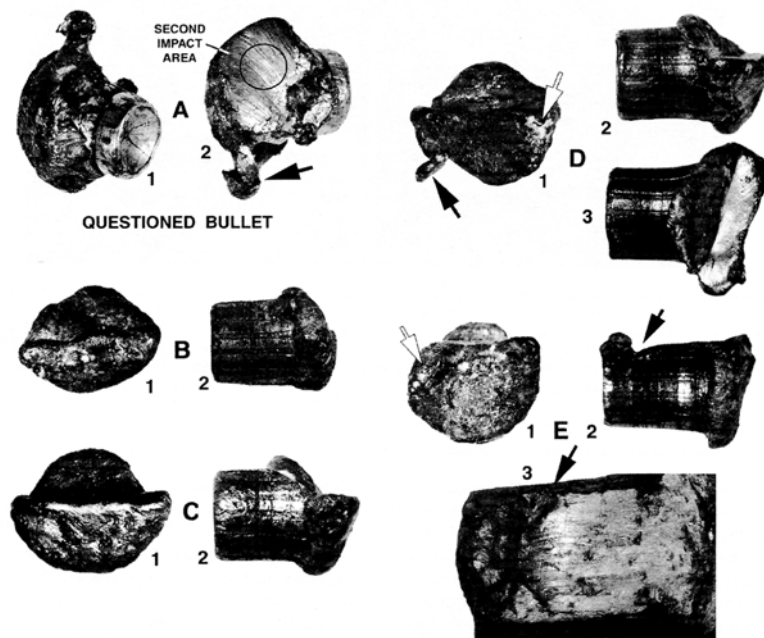
The medical examiner testified that the bullet entrance hole in the victim appeared to be from a larger caliber (i.e., the bullet was likely mushroomed prior to striking the victim). It also appeared that the .22 missile had hit a second object after mushroom formation in that there is a scrape mark on the mushroom of the bullet (Fig. 2A-2).

Some of the test .22 bullets show the result of striking a window crack near the center of the bullet (Figs. 2B, 2C, and 2D). The breakage of the glass on one side of a crack before the other may result in a "step" feature in the mushroom of the bullet as shown in some of the test bullets (Figs. 2B, 2C, and 2D). These features on the bullets make it clear that one side of the glass on a crack is often more resistant to failure than the other. Usually, when the glass fails on one side of a crack, it goes all at once. However, a nonuniform failure may have occurred for the bullet shown in Fig. 2D in that this bullet rotated approximately 20° from center (Fig. 2D-3) before the first side of the glass on the crack failed. The second side of the glass failed with the bullet remaining at approximately the same angle.

Another of the test bullets (Fig. 2E) showed a particularly interesting result of a strike near the edge of the bullet at a window crack. For this bullet, as in the bullets shown in Figs. 2B, 2C, and 2D, the glass on one side of the crack failed before the other. However, in this case the bullet did not break free of the unbroken side of the glass until the bullet was scraped almost its entire length by

the glass edge. Near the base of the bullet, the gouging by the glass edge deepened into the bullet (Fig. 2E-2, arrow) which apparently resulted in the glass edge breaking before the bullet was clear of the glass. Tool-mark-like striae are present (Fig. 2E-3, arrow). Most likely the scrape marks on the anterior portion of this test bullet were almost completely obliterated from friction by the cotton fibers of the bullet collection box.

FIG. 2—A: The .22 bullet taken from the victim at autopsy. Circle: area examined by SEM/EDS. Arrow: lead spur. B: Test .22 bullet that was shot through window glass at a crack. C: Test .22 bullet that was shot through window glass at a crack. D: Test .22 bullet that was shot through window glass at a crack. White arrow (on D-1) points to a concentration of powdered glass. Black arrow (on D-1) points to a lead spur. The bullet shown in D-2 is rotated 90° in D-3. E: Test .22 bullet that was shot through window glass at a crack. White arrow (on E-1) points to a concentration of powdered glass. Black arrows (on E-2 and E-3) indicate a dip in the gouge into the bullet body caused by the window glass. The scrape area of bullet shown in E-2 was rotated 90° and enlarged in E-3.

An occasional feature of a .22 bullet that hits glass is the creation of a lead spur on the mushroom of the bullet (e.g., Fig. 2D-1, arrow). This appears to be created by a small lead flow away from the main body of the mushroom during the bullet's strike on the window. The victim's bullet has a lead spur (Fig. 2A-1, arrow).

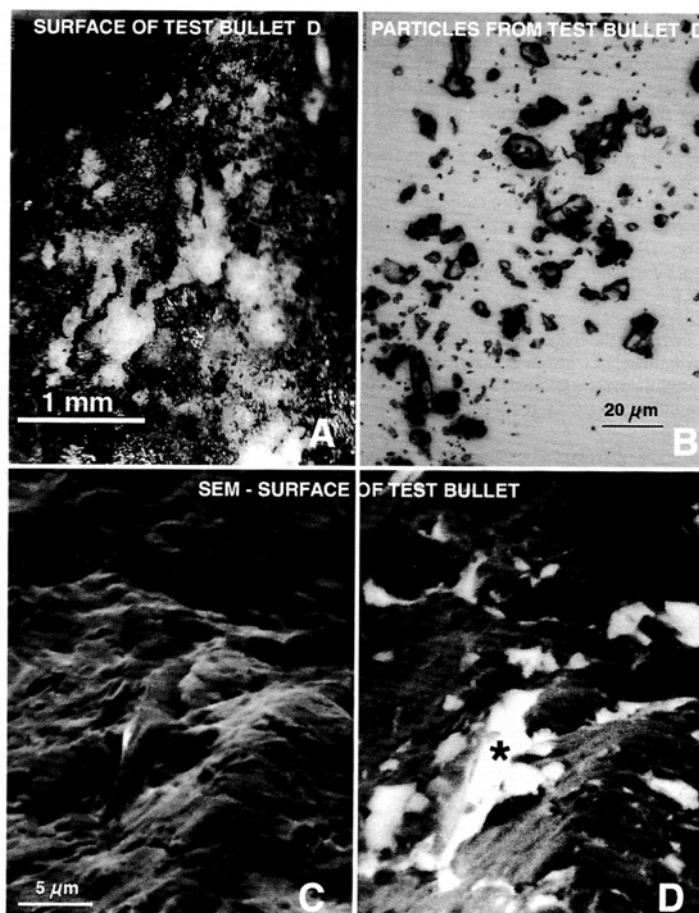
In the test shots through the window, the mushroomed surfaces of many of these bullets show regions of white powder (Fig. 2D-1, white arrow; Fig. 2E-1, white arrow, and Fig. 3A). Particle sizes range from less than 0.5 to almost 20 μm (Fig. 3B). Analysis by EDS reveals these particles to have the same composition as that of the test window glass (see Fig. 5C). Scanning electron microscopical examination of one of the mushroomed test bullet's surface shows the fragments of glass (Figs. 3C and 3D), some of which are embedded in the bullet's lead surface (e.g., Fig. 3D, asterisk).

FIG. 3—Observations of the bullet and associated particles from the test window shots. A: A concentration of powdered glass from an area on a test bullet. Even at a magnification of $70\times$ through a stereomicroscope, individual glass particles could not be resolved. B: A portion of the sample from the powder that was spread onto a slide and imaged through a compound microscope. By SEM/EDS, these same particles were identified as window glass. C: Scanning electron microscope—secondary electron image of the surface of a test .22 bullet that was shot through a window. D: The same area and magnification as 3C, but a reverse backscatter electron image. The white features (low backscattering relative to the bullet's lead surface) are glass fragments, one of which is embedded (asterisk) in the lead.

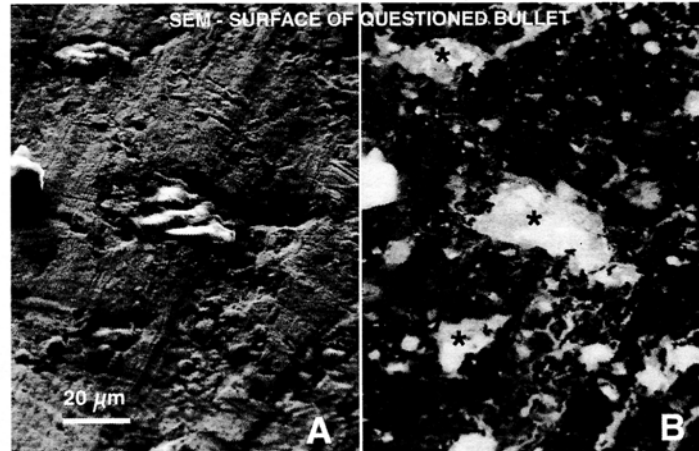
bedded in the bullet's lead surface (Figs. 4A and 4B). Spectra (e.g., Fig. 5A) taken of these particles show that they have essentially the same composition as that of the window glass fragment found at the crime scene (Fig. 5B). Glass from both the test window and the crime scene window have similar compositions (Figs. 5B and 5C). Comparison of a spectrum of a glass particle embedded in a test bullet (Fig. 5D) with a particle embedded in the victim's bullet (Fig. 5A), also show a close similarity. It is likely that the embedded particles in the victim's bullet are from the crime scene window glass.

FIG. 4—Scanning electron microscopy of the .22 bullet from the victim in the region of the second impact zone (within the black circle in Fig. 2A). A: Secondary electron image. B: The same area as A, but a reverse backscatter electron image. The white features (low backscattering relative to the bullet surface) appear to be glass fragments and tissue debris. The apparent glass fragments (asterisks) are embedded in the surface of the lead.

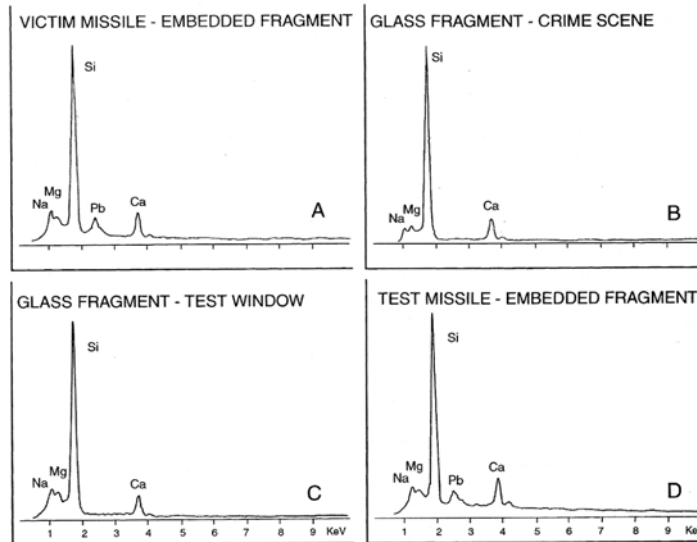
FIG. 5—Energy dispersive X-ray spectra. A: Spectrum of an apparent embedded glass fragment from the victim's bullet. B: Spectrum of a glass fragment recovered from near the crime scene window. C: Spectrum of a glass fragment from the test window. D: Spectrum of an embedded glass fragment from a test bullet.

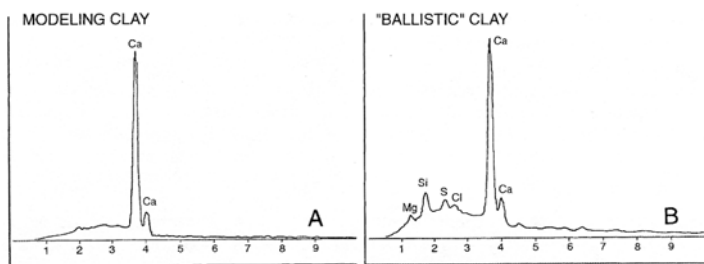
Three recently purchased (ca. 1996) samples of modeling clay, one of which was used for bullet mounting in a comparison microscope in the author's laboratory, were analyzed in the scanning electron microscope with a beryllium-window energy dispersive X-ray analyzer. All these samples showed calcium without other elements (Fig. 6A). Four samples of a clay-like substance found in

the metal bullet mounts of an approximately 50-year-old B&L comparison microscope all showed varying amounts of silicon and magnesium (likely talc), sulfur, chlorine, and calcium (e.g., Fig. 6B). Calcium predominates in all of these samples. There is no similarity between the spectra of window glass (e.g., Fig. 5B) and that of any of the clay and clay-like samples.

FIG. 6—Energy dispersive X-ray spectra. A: Spectrum of a cream-colored modeling clay used for bullet mounting in the Forensic Science Consulting Group's laboratory, Cardiff, California, 1996 through 1998. B: Spectrum of a clay-like substance found in the metal bullet mounts of an approximately 50-year-old B&L comparison microscope.

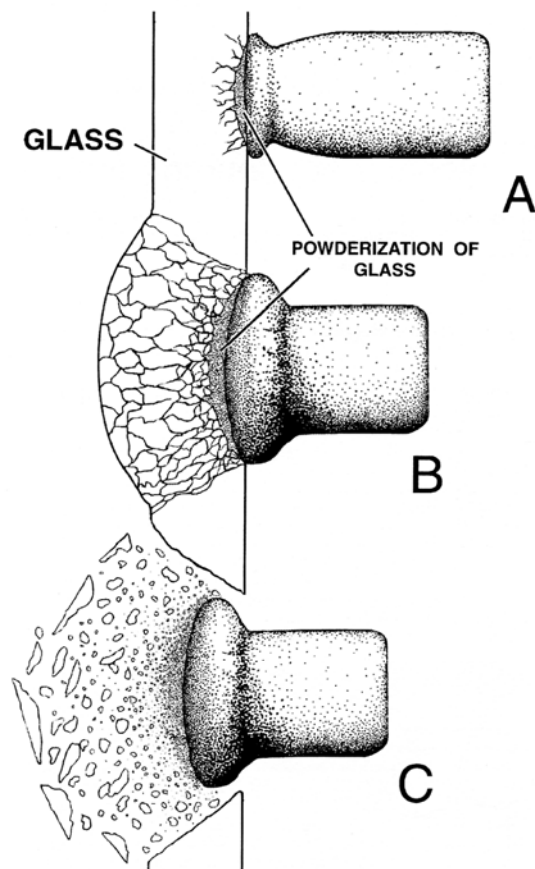
FIG. 7—Proposed sequence of events when a .22 bullet hits window glass. A: Early in the contact of the bullet with the glass. Simultaneous with the start of mushroom growth is the generation of fine glass fragments associated with the mushroom. B: The bullet at completion of mushroom formation and glass failure. C: The bullet breaking through the glass with the generation of large glass fragments. Not to scale.

A summary of the bullet interaction with window glass is given in Fig. 7. A .22 bullet is shown early in a strike on window glass in Fig. 7A. The window glass at the bullet contact does not fail immediately, but remains intact long enough for the mushroom to form. With the mushroom formation, the high pressure and temperature imparted by the bullet into the glass, powderizes the glass directly associated with the bullet mushroom. When the pressure on the glass reaches a critical point, the glass fails (Fig. 7B). The final stage is the punching of the bullet through the window with the creation of relatively large glass fragments in front of the powdered glass layer and the cone-shaped defect in the window (Fig. 7C). In this scenario, the .22 bullet does not come into contact with the large glass fragments at the time of passing through the window glass.
