Failure of a Security System Due to Motion Sensor Cover Failure

By Bryan Burnett

Abstract: Six security motion device covers were received for analysis following apparent failure of the security system in a tire/brake store burglary. Four of the covers of these thin plastic sheets were from failed devices and two were controls from normally operating devices. The covers were examined by normal light, ultraviolet light and scanning electron microscopy/elemental analysis. The submitting party suspected that some sort of material was sprayed on these covers, rendering them inoperative. The results of these analyses provided no evidence of human manipulation. Rather, it is apparent that environmental factors likely caused the degradation of the plastic covers which resulted in the failure to allow the radiation specific to the motion detector to pass.

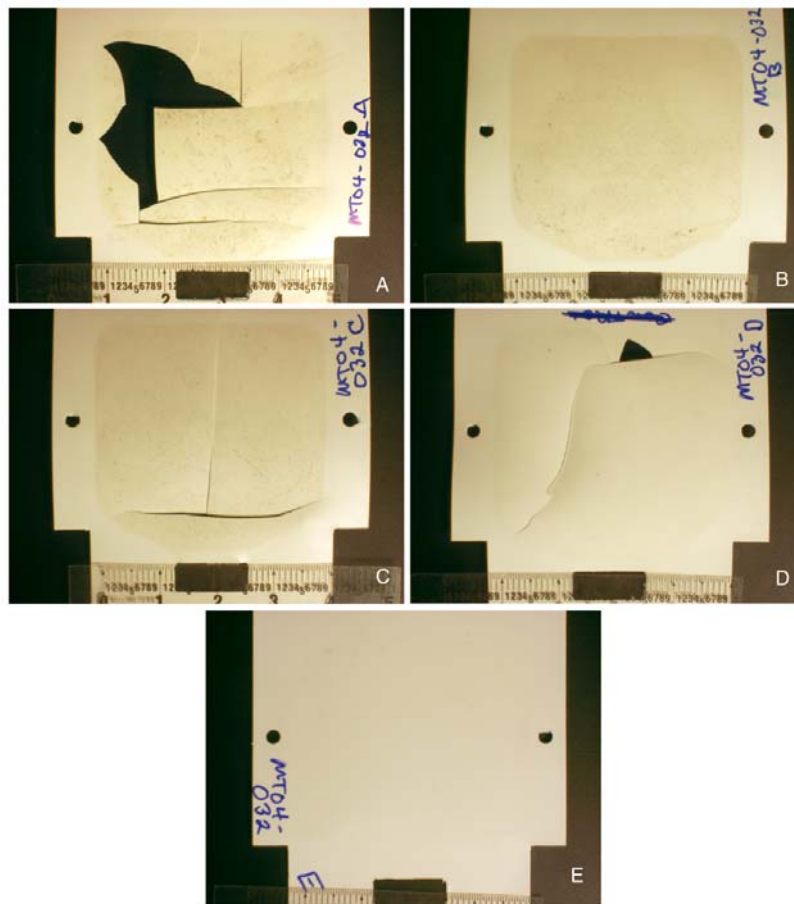
Figure 1. Images of five of the six plastic sensor covers. A through D: the covers from the sensors that were described as having failed. E : the control cover from a normally operating sensor that was included with the other covers.

1. Three of the four failed covers were excessively brittle (Figs. 1A, 1C and 1D).
2. Three of the covers surfaces (Figs. 2A, 2B and 2C) were discolored and had embedded debris. Sample D's surface (Fig. 2D) appeared similar to the controls (Figs. 2E and 2F).
3. The transmittal of UV light through the plastic covers was variable. Samples A and D (Figs. 3A and 3D) allowed some passage. Sample B (Fig. 3B) appeared to be opaque in comparison to the others. Sample C (Fig. 3C) appeared to transmit a little more than the control sample E (Fig. 3E).

It is apparent that the sensor covers at issue were in an environment that has changed the properties of the cover plastic. A feature of this change is the cover plastic has become brittle (Figs. 1A, 1C and 1D) which suggests a loss of plasticizers. Such a loss likely changed the optical properties of the plastic. Other attributes examined (UV light transmittance and scanning electron microscopy) do show differences between covers and may factor into transmittance by the covers. But, these may be secondary to plasticizer loss. The bottom line is that these covers lost their ability to transmit the wavelength of radiation necessary for the proper functioning of the motion detector without an apparent foreign substance coating the surface.

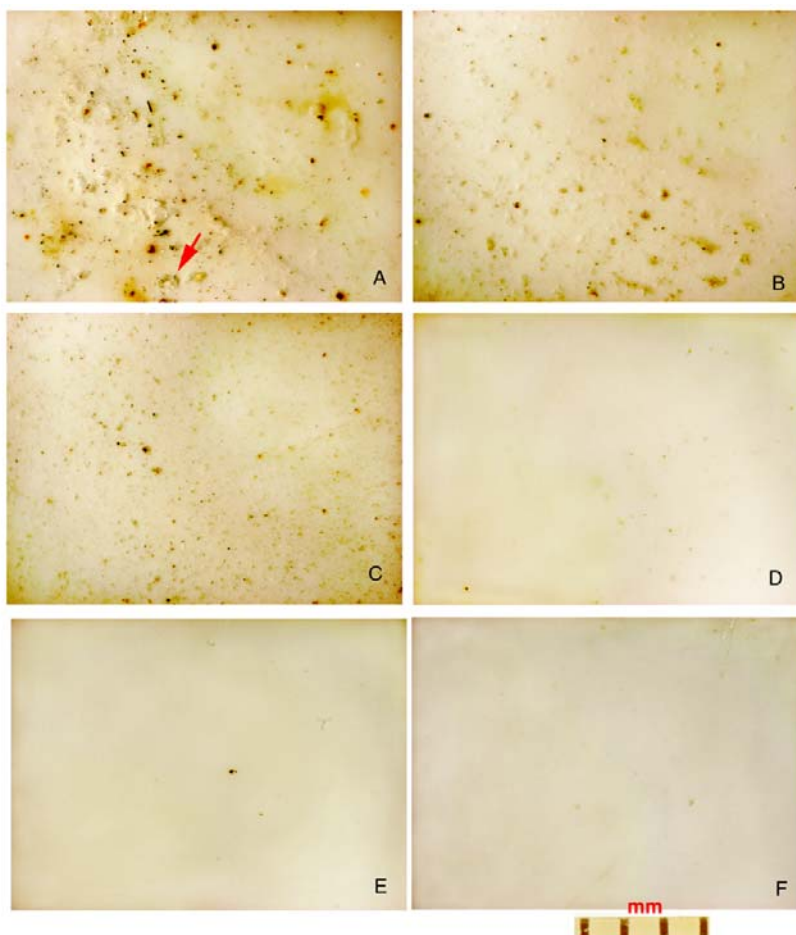
Figure 2. A through D: Stereo microscope images of the exterior surface of the four failed covers. Arrow, an apparent salt crystal. E: The control sample surface of the cover that was included with samples A through D. F: The second control sample surface.

1. There is no evidence that any material was painted or sprayed on the covers.
2. The accumulation of apparent foreign material on three of the covers (Figs. 2A, 2B and 2C) does not provide an explanation for the failure because cover D (Fig. 2D) appears free of debris.

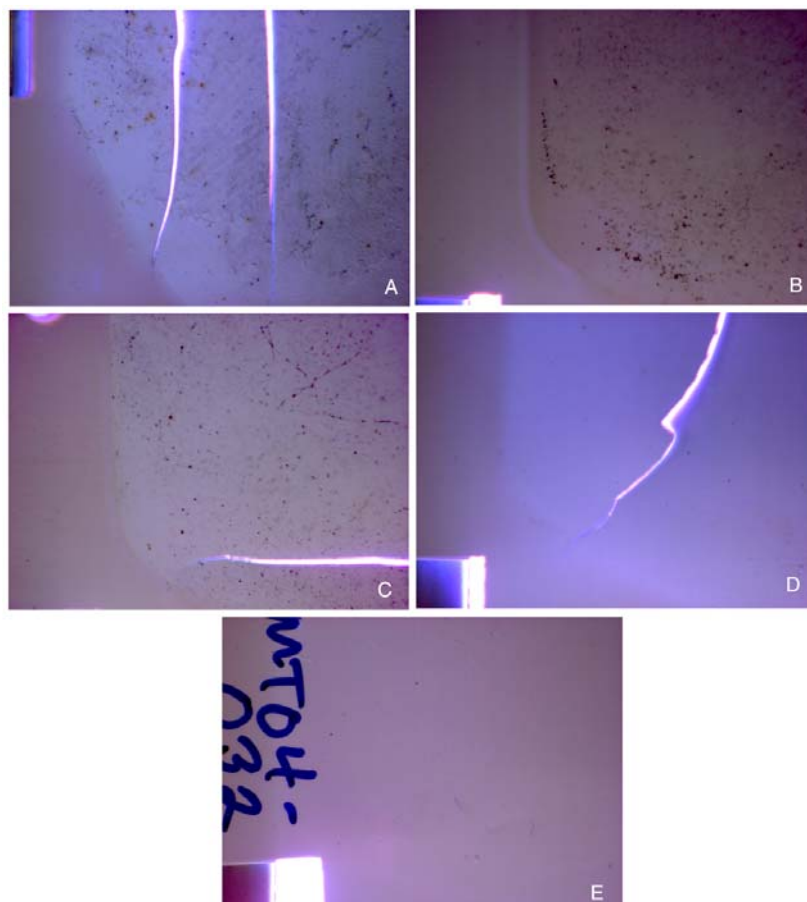
Figure 3. Ultraviolet light transmission through the covers. A through D: the failed sensor covers. E: the control sample. The Pixera 600CL digital camera's auto gain was fixed at a constant sensitivity for all these images.

3. The covers were variable in transmittance of UV light, where covers A and D (Figs. 3A and 3D) showed the most transmittance. Cover B (Fig. 3B) appeared to overly block transmittance. Cover C (Fig. 3C) is similar to the control (Fig. 3E) in this regard. The changes in the properties of the covers affecting UV transmittance do not provide an explanation for the apparent failure of these covers.

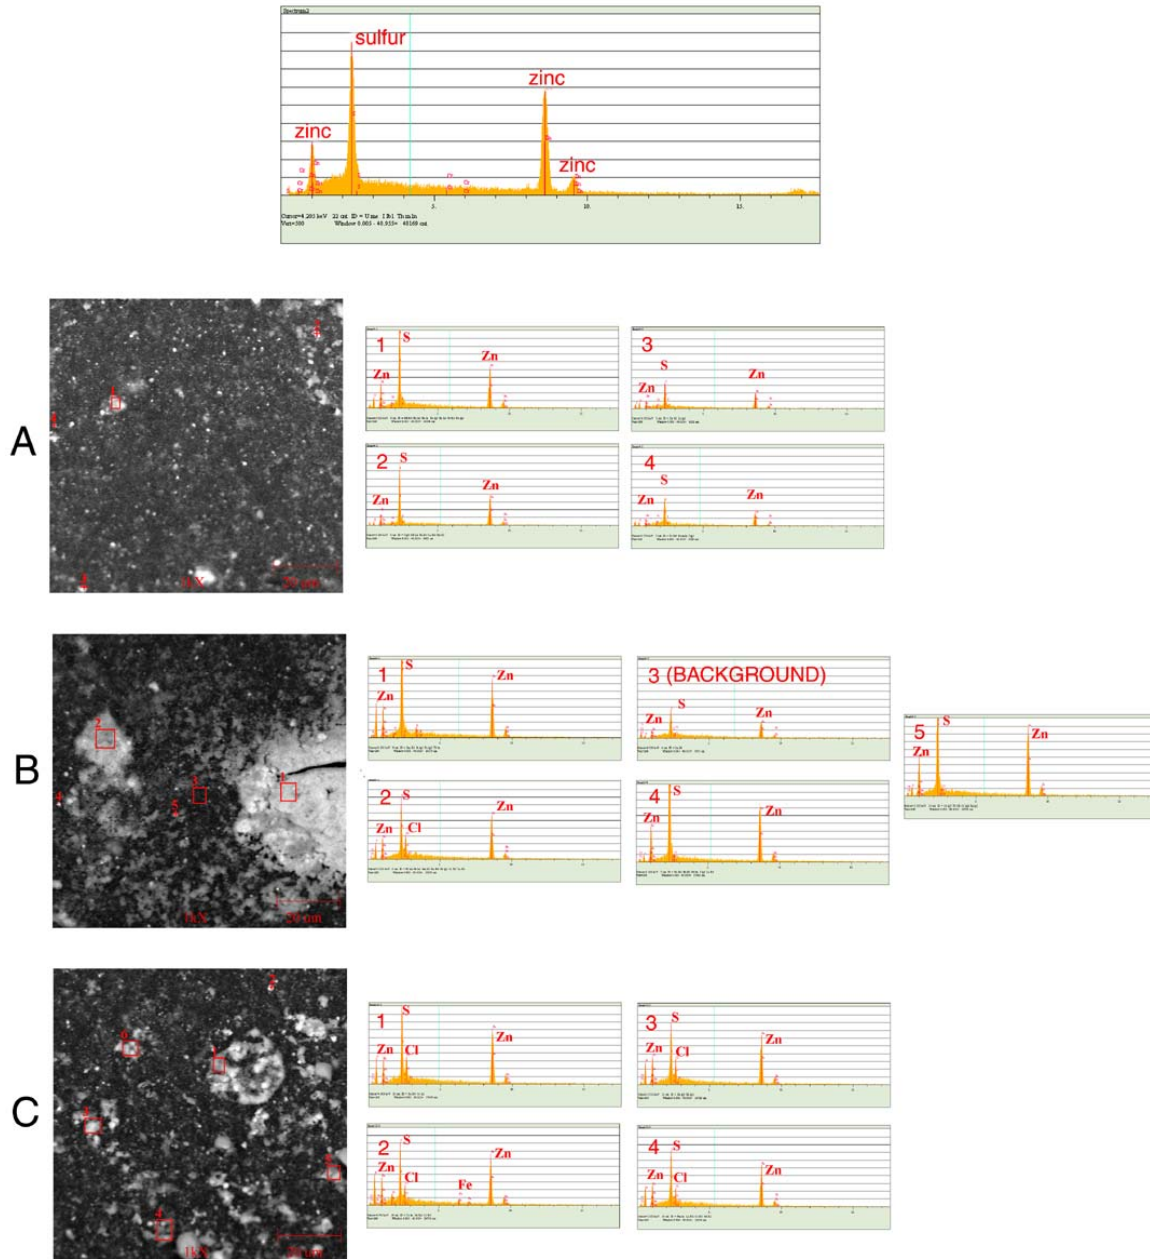
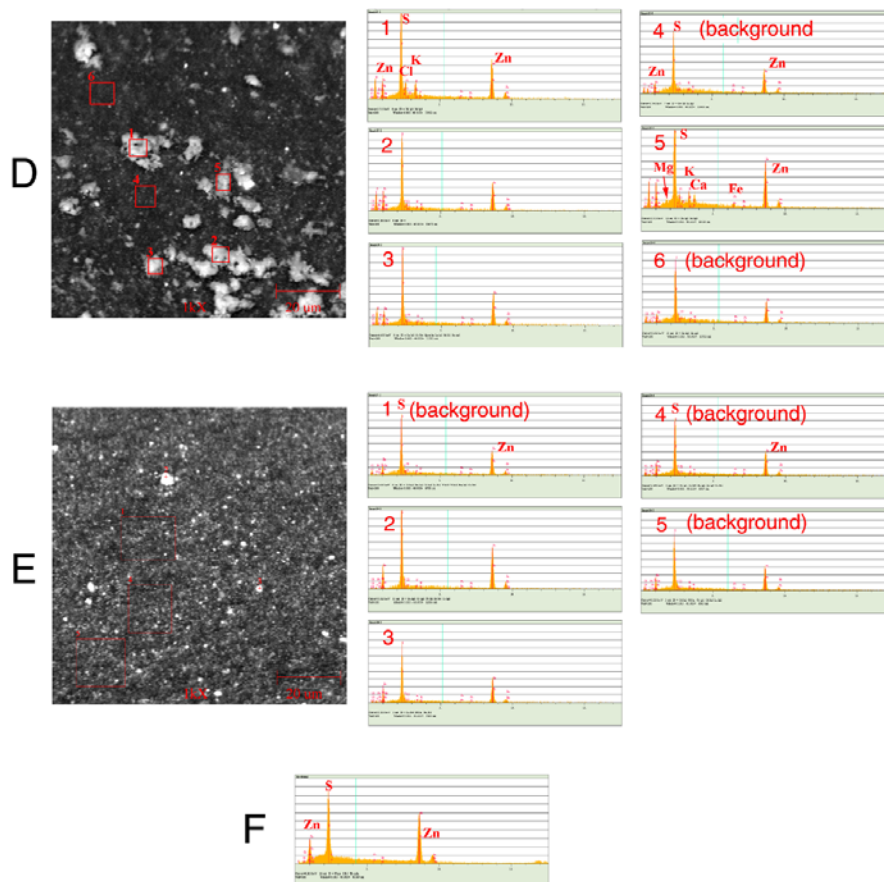
Figure 4. Continued

4. Backscatter electron images and associated spectra are shown in Fig. 4. Zinc (Zn) and sulfur (S) with oxygen (O) predominated in all the samples, including the controls. These images and spectra show the zinc and sulfur are usually associated by having near constant relative elemental concentrations throughout most of the sample spectra. There is, however, an apparent redistribution of these elements in some samples (e.g., Fig. 4B) where the amount of sulfur and zinc off the particles was much less than that on the particles. The controls (Figs. 4E and 4F) show that Zn and S are a normal part of these covers. There are obvious contaminate particles mostly composed of sodium (Na), silicon (Si) chlorine (Cl) and Potassium (K). A few particles were found that had titanium (Ti). All of these particles were rare, on the scale (at 1000x) examined in the Scanning electron microscope. Sample A appeared to have crystals of sodium chloride scattered on its surface (Fig. 2A, arrow).

Figure 4. Backscatter electron images of the sample surfaces and associated spectra for the samples. Top: sample spectrum showing the locations of the element peaks of interest (sulfur and zinc) in these samples. A through D: Samples from the failed sensors. E: control sample. F: second control sample (spectrum only). The light areas in the images are areas of more dense accumulation material (backscatter electron detection displays differences in density, or atomic number, of a subject)

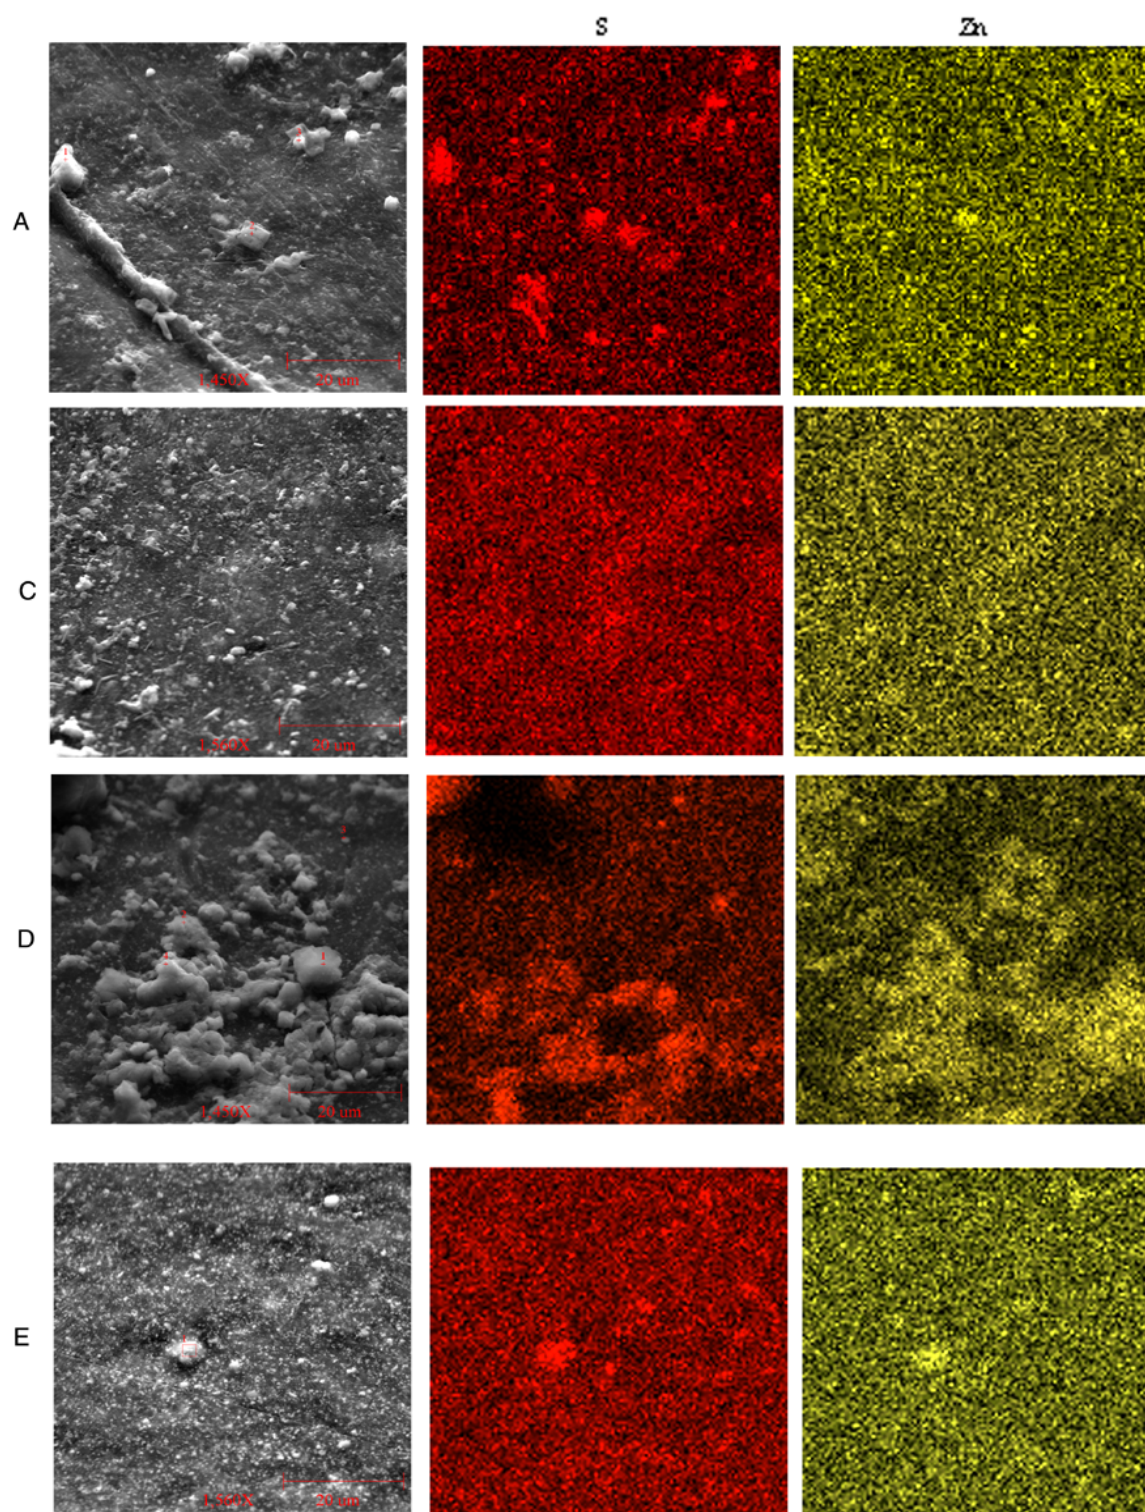
5. Element maps of the two principle elements, zinc and sulfur, are shown in Fig. 5. How this is performed is the beam in the electron microscope is slowly traversed across the specimen. When X-rays of the sulfur and zinc are recorded, a dot is placed on the sulfur or zinc map image. It takes approximately 15 minutes to complete a map. Map samples A and D, which are from the suspect covers, show that both sulfur and zinc are capable of redistribution. The particles, especially in sample D, show concentrations of zinc and sulfur. Sample D also shows that these elements are not correlated in parts of the map. Sample C appears more like E (the control) where sulfur and zinc are fairly evenly distributed.

4. The zinc-sulfur (likely zinc sulfate) was probably applied to the cover plastic by the manufacturer to inhibit microorganism growth when in moist environments. Apparent movement of the zinc into accumulations (in a different form) on the cover surface may cause a transmittance problem for a motion detector. But, this apparent transformed material is found more on three covers (Figs. 4B, 4C and 4D) than on cover A (Fig. 4A) and the control (Fig. 4E). Thus, changes in zinc and sulfur distribution on the covers cannot offer an explanation for the cover failure.

Figure 5. Elemental maps of samples A, C, D and E. The secondary electron image (real images of the surface) is on the left, the sulfur map is middle and zinc map is on the right. A, C & D : samples from the failed sensors. E : control sample.
