# **Staged Suicide**

## Bryan R. Burnett <sup>a</sup>\* Cataldo Raffino <sup>b</sup> John D. Sabow <sup>c</sup>

# ABSTRACT

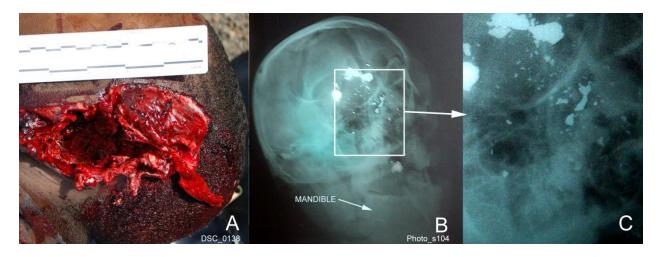
**Fig. 1.** (A) Image of the left side of the victim's head showing the massive defect caused by the 12 gauge shotgun's discharge; the autopsy report determined this is the entrance wound [2]. (B) LL projection X-ray of the victim's head shows lead projectiles; one of the shotgun pellets is at the victim's upper jaw, overlapping his teeth. Image enhanced by Image/Adjustments/Levels routine. (C) Enlargement of the area within the rectangle in B showing numerous fine particles from lead shot fragmentation.

Multiple lead pellets and fragments within the victim's head (Figs. 1B and 1C) were shown in a LL projection X-ray image. The shotgun discharge was not intraoral, although the entrance/exit wound (Fig. 1A) appears similar to an exit wound for an intraoral shotgun discharge [15].

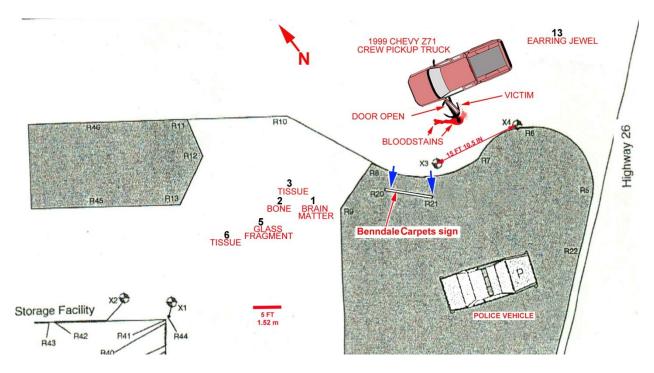
Figure 2 is a graphic to scale of the shooting scene, which was revised from the poor photocopy of the graphic of the scene provided in the discovery. The locations of evidence items 1 through 5 and 13 are shown.

**Fig. 2.** The shooting scene drawing provided in the discovery; the victim, truck and bloodstains graphics were redone due to poor copy quality. The truck's driver side door was open and the victim was lying under it. The red graphics/lettering by the author and the scale of the scene drawing was verified. Blue arrows indicate the locations on the Benndale Carpets sign that was hit with blood/tissue spatter.

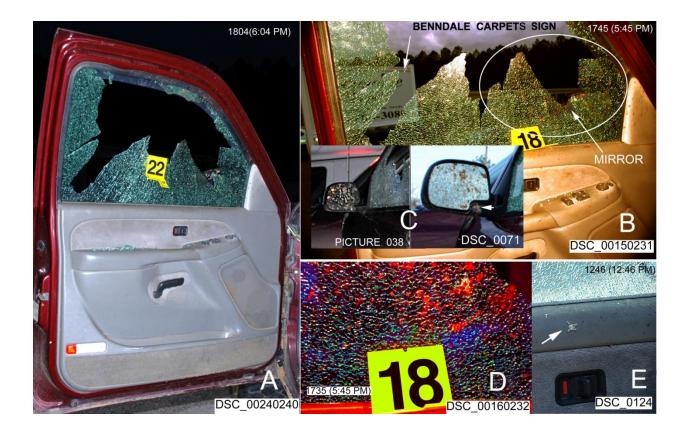
Figure 3A shows the interior driver side door of Johnson's truck. Blowback is evidenced by blood and tissue coating a part of the window's remaining tempered glass fracture mosaic (Fig. 3B circled area). Tissue debris also coated the door mirror (Fig. 3C) which is added evidence that the victim's head was quite close to the window at blowback. A close-up image of the remaining window shows the extent of the blood and tissue covering it (Fig. 3D lower left circled area of Fig. 3B).

**Fig. 3.** (A) The driver side interior door of the victim's truck showing the window's tempered glass fracture mosaic. (B) The image of the interior door window has been color adjusted using Photoshop: Image/Adjustments/Color Balance to show extensive blood/tissue spattering on the window. (C) Two images of the driver side door mirror that shows the extensive tissue spattering. (D) Close-up of the window where red is enhanced in Photoshop: Image/Adjustments/Color Balance followed by Vibrance to show a coating of blood and tissue at the lower left part of the window circled in B. The tempered glass mosaic near evidence marker 18 showing extensive spattering of tissue; Photoshop: Image/Adjustments/Color Balance followed by Vibrance. (E) The victim's earring base attached to the windowsill at the arrow. Only small spatters are on the windowsill.

The victim's earring post was attached to the lower windowsill (Fig. 3E, arrow) and its jewel separated and deflected off the sill to the location indicated in Fig. 2 (evidence item 13) due to the shotgun blast. There was no blood association with the surface of the door sill surrounding the earring post, which indicates that the earring was blown from the victim's pinna by the shotgun blast, not by blowback. The distance from the truck's driver side door to the earring jewel was approximately 6.7 m (22 feet). The earring jewel separated from its post in the shotgun blast, bounced off the door windowsill to the pavement at the rear of the victim's truck (Fig. 2, item 13). The left side of the victim's head was estimated to be 10 to 15 cm (4 to 6 inches) from the door window for this to occur.

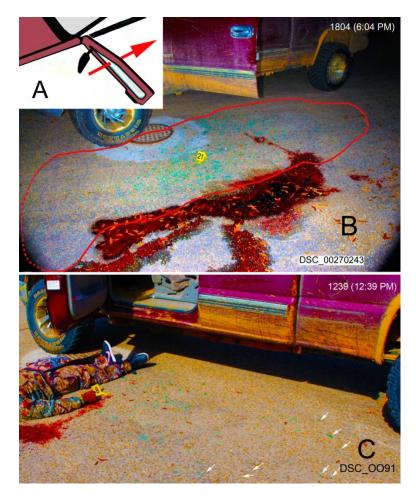
**Fig. 4.** (A) Graphic showing the direction of the initial breakage from the driver side door window that projected glass shards toward the rear of the truck. (B) Distribution of glass shards on the pavement with the body removed (time stamp 1804 (6:04 PM)); the glass shards on the pavement were from the initial breakage with shard projection to the rear tire. The red outlined area is the approximate demarcation of the glass shards on the pavement. The red line is dotted on the left due to the glass shards projection further than shown in the image. Adjustment by Photoshop: Image/Adjustments/Vibrance tool accentuates the glass shards (blue) on the pavement. (C) Distribution of glass shards on the pavement (time stamp 1239 (12:39 PM)); the glass shards on the pavement extend to the rear tire. Adjustment by Photoshop: Image/Adjustments/Vibrance tool accentuated the glass shards on the glass shards (blue) on the pavement. Due to the different ambient light from image B, not all the glass shards are color accentuated by this Photoshop application.

Glass shards were deposited onto the pavement from the driver side window at three different times. The first occurred from the initial breakage/fracturing where the breaking force was to the outside of the open door (Fig. 4A) and had sufficient force to project glass shards as far as the rear tire of the truck (Fig. 4B and 4C). Only one glass shard was found on the victim's clothing (Fig. 6A, at arrow) and none on his left shoe (Fig. 6A, insert). If the victim was standing within the area of the shard projection at breakage, the area of glass shards on the pavement without a void, and the lack of numerous glass shards on his clothing indicate the victim was not within the glass shard projection.

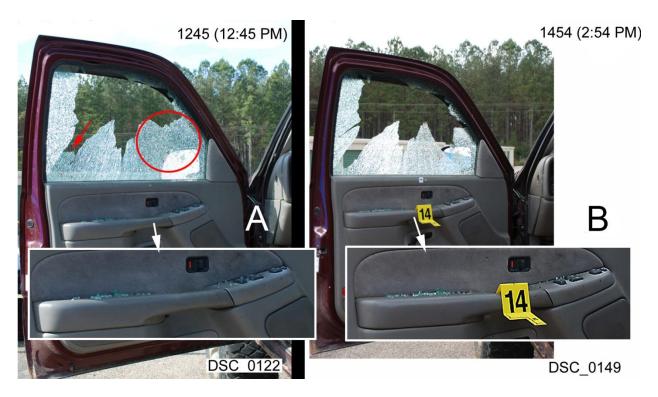
**Fig. 5.** (A) The appearance of the truck window from the time of initial breakage before the shooting to early afternoon (image time stamp is 1245 (12:45 PM)); the circled area has the spattered blood and tissue from blowback as well as loss of glass (see B). Red arrow points to additional glass loss shown in B. Backlighting prevents seeing blood and tissue coating on the window in this image (see Fig. 3C). Inset: enlargement of armrest showing accumulation of glass shards from the initial window break. (B) Image shows collapse of some of the glass from the window, which occurred between 1245 (12:45 PM) and 1454 (2:54 PM); the inset of the armrest glass shards shows little change from A. This indicates that the additional collapse of the tempered fracture glass mosaic was mainly toward the exterior side of the open door.

Between 1246 (12:46 PM) and 1454 (2:54 PM) a portion of the fractured tempered glass still in place (Fig. 5C) collapsed (Fig. 5D) onto the pavement (third deposition). This deposition was mostly exterior to the open truck door and away from the body. Some of the glass fell on the armrest on the interior side of the door (compare the armrest images (insets) Figs. 5C to 5D).

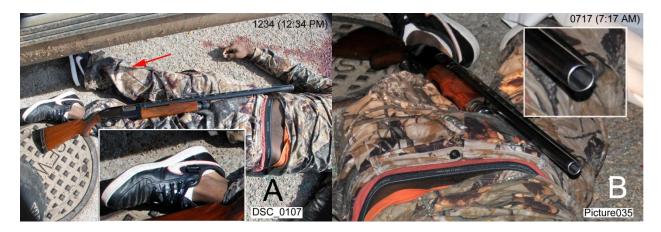
**Fig. 6.** The Sears M200 12 gauge shotgun. (A) Despite being identified as the source of the fatal wound to the victim, the shotgun had no associated blood or tissue; inset: enlargement of the victim's left shoe showing no associated glass shards. Arrow: points to the single glass shard on victim's pant leg. (B) Another view of the shotgun; tissue and blood would be expected to cover the victim's shotgun if this was the shotgun used in his death. Inset: the bore of the shotgun at the muzzle shows no blood or tissue.

The shotgun barrel should have been hit with blood due to the massive blowback, brain tissue, etc., which usually occurs in either suicide or homicide scenarios by a near contact shotgun discharge to the head [15]. The exterior of the shotgun showed no tissue contamination (Figs. 6A and 6B). No tissue was within the bore of the shotgun (Fig. 6B, inset). Another shotgun discharged into the victim's head.

The 12 gauge shotgun has the strongest recoil of most firearms [19]. The trajectory of the pellets in the head [2] and the blowback occurring near the truck door window (Fig. 3) would have the shotgun elevated off the ground and unsupported in the suicide scenario. The close proximity of the victim's head to the door window and the angle at the shotgun's discharge would mean more than half the shotgun would be on the exterior side of the door window. In the suicide scenario, the victim somehow managed to reach the trigger on the exterior side of the window after breaking it with the shotgun stock. Upon the discharge in this scenario, the unsupported shotgun recoil would propel it through the widow, away from the victim. The victim's shotgun was on top of his body (Fig. 6).

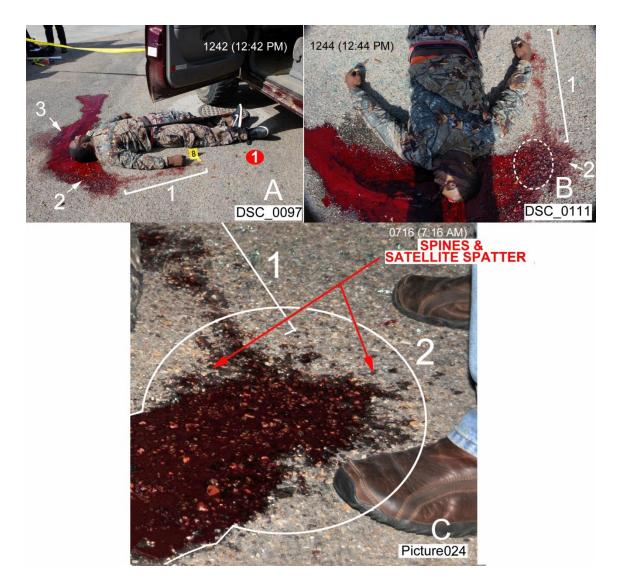
**Fig. 7.** Pavement bloodstains; stain numbers 2 and 3 correspond to the numbered body positions. The body is in position 3 in these images. (A) Image of the body and associated stains; blood trail 1 documents that the body was moved from the position where he collapsed (at the red dot) following the shotgun discharge. Blood trail 1 goes from the stain just in front of the right hand to the larger stain 2. Bloodstain 3 originated from the body at position 3 as shown. (B) As in A, but image was taken with the photographer standing near the victim's head with his shadow over the body; the dashed line oval is the probable location of the victim's head in body position 2. (C) Image of stains 1 and 2; a spattering event (splash pattern) occurred in circled area of stain 2 when the head was elevated above the pavement prior to setting the body down in position 2. The blood came from the massive, vessel-like head wound (Fig. 1A) when the head was turned to the left while elevated above the pavement, poring blood onto the pavement which created a pool with the spines and satellite spatter due to splashing. Image probably taken at 0616.

The victim almost vertically collapsed after the shotgun discharge. The bloodstains labeled 1 in Fig. 7 show a trail, which originated from the initial victim collapse location (at the red dot in Fig. 7A). The trail leads to a blood pool. Blood had quickly filled the massive vessel-like head

wound and creating a splash pattern (Fig. 1A) when the victim's head turned left while he was elevated above the pavement. Blood spilled from the vessel-like wound and into the developing pool, the blood-into-blood splashing created spines and satellite spatter (Fig. 7C).

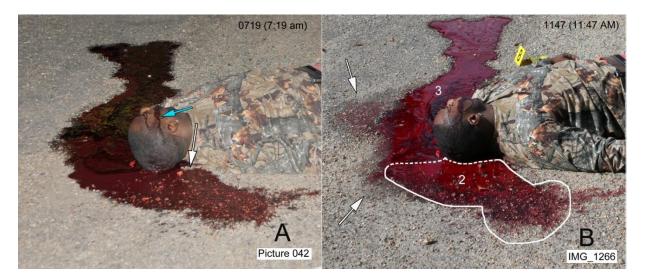
**Fig. 8.** Bloodstains 2 and 3 and the result of covering the body with a sheet. (A) Image taken at 0719 (likely ~ 0619 (6:19 AM)) showing a gap in the stain near the victim's neck (at white arrow) which was not present in the images taken later. Blood flow from the victim's mouth occurred when his head was facing up or to the right (at blue arrow). (B) The stain gap at the arrow in A provides demarcation estimation between the blood deposited when the body was at position 2 (Fig. 7) and the final position 3 of the body. Bloodstain 3 originated from the final position of the body. The white outline is the estimated extent of the stain when the body was at position 2 to where the blood flow from body position 3 added to the stain from the victim at position 2 (estimated at dashed line). Arrows point to the stains caused by blood and serum wicking by the cloth sheet placed over the body.

A demarcation between the bloodstain pool deposited when the body was on the pavement at position 2 and the final position can be seen in Fig. 8A at white arrow. The blue arrow in Fig. 8A points to blood flow from the mouth when the head was face up or turned to the right. The extent of stain 2 is outlined in Fig. 8B. The dashed line approximates where bloodstain 2 merged with stain 3.

The consequence of the sheet covering the body is a modification of the bloodstain. Figure 8A is an image of the unmodified bloodstain. Figure 8B, taken more than four hours later, shows the result of the placing a sheet over the body. Blood and serum wicked by the body-covering sheet created blood/serum stains (Fig. 8B at arrows) from the large blood pool.

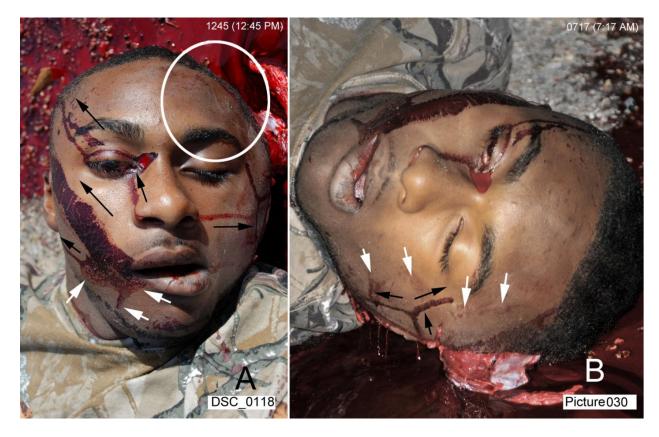
**Fig. 9.** (A) Bloodstains on the victim's face; black arrows indicate the direction of blood flow when each stain was created. The head had changed positions from the time of the shotgun discharge to the position shown in the scene images. The victim's forehead came in contact with dirt (circled). The white arrows point to a blood wipe that occurred immediately after the shotgun discharge by an assailant's hand when the body was being moved. (B) Transfer stains (white arrows): the time stamp on this image was likely 0617 (6:17 AM) or within one hour of the shotgin occurred, which are reflected by the Y-shaped stain. These streams could not have occurred in the found body position. Black arrows show the direction of the blood flow. Transfer stains (at white arrows) occurred before the "Y" arms of the bloodstream. This image was color adjusted by Photoshop/ Image/Adjustments/Hue-Saturation.

The bloodstains on the face of the victim (Fig. 9) provide additional evidence of the movement of the body immediately after the fatal shot. Dirt on the victim's forehead (Fig. 9A, circled area) indicates that his left forehead came into contact with the pavement. The black arrows in Fig. 9A show blood flow directions. The stains on the victim's right face (Fig. 9B) show his head, face down) was on pavement for a short time. This blood, which originated from his mouth, flowed along his cheek and then to the ground and may have contributed to the stain trail 1(Fig. 7). Another source for stain trail 1 was likely from the massive shotgun wound on the left side of the victim's head (Fig. 1A).

A blood wipe was on the victim's face (Fig. 9A, white arrows). Its dried appearance, like the large blood flow from the victim's mouth to his right pinna, indicates that these two stains occurred within a short time, likely seconds, of each other. The victim's head was initially near the evidence marker 8 in Fig. 7A, immediately following the shotgun discharge.

The Y-shaped blood flow on the victim's left face (Fig. 9B), which originated from the shotgun wound, indicates changes in the head positions occurred within seconds following the wounding. The base of the Y stain (Fig. 9B) shows that the victim's head was face down immediately after wounding and his forehead likely contacted the pavement. The head position momentarily became vertical (the left arm of the Y-shape stain), which was followed by the head angle changing to a third position (the right arm of the Y-shaped stain). The latter blood flow was approximately at the same angle as the blood flow from the victim's mouth on his right face (Fig. 9A).

Before the creation of the two arms of the Y-shaped bloodstain, multiple transfer stains (Fig. 9B, white arrows) are on the victim's left face, under the two arms of the Y-shaped stain. The victim's head/body was manipulated immediately after the shotgun discharge by blood-contaminated hands.

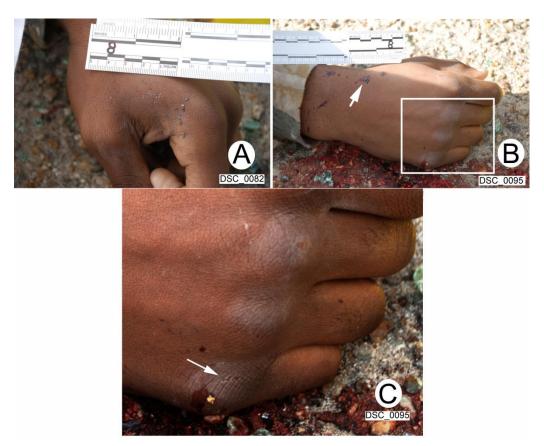
**Fig. 10.** (A) Left hand of the victim; the hand was in contact with the road pavement where it picked up dirt. (B) Right hand of the victim; the bloodstain at arrow has dirt associated; the outline area enlarged in C. Arrow points to road dirt associated with bloodspatter. (C) An enlargement of the outlined area in B showing the victim's knuckles were abraded; a small amount of skin was more deeply abraded at the arrow.

The victim's hands had dirt on them (Figs. 10A and 10B) indicating that these surfaces had been in contact with the pavement before body position 3. The right hand knuckles (Fig. 10C) also had abrasions, which were not reported in the autopsy report [2]. The victim appeared to have been punching at his assailants before his death although he could have obtained these abrasions in a high school football game two days earlier. But an image of the victim showed he was wearing gloves at a football game [20].

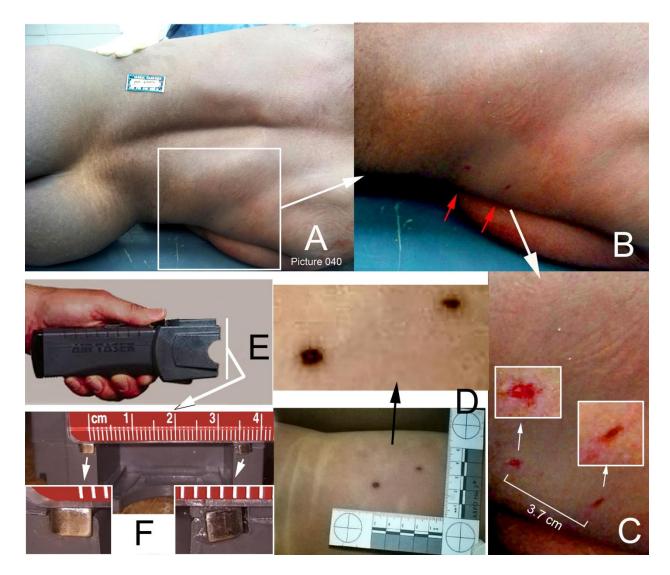
Two small wounds were on the victim's right lateral mid-lumbar region (Fig. 11A and Fig. 11B at red arrows). Notable is a halo of hyperemia approximately 10 cm from the wounds (Fig. 11B). The inferior wound (Fig. 11C, left) appears superficial, dispersed and roughly square. The superior wound (Fig. 11C, right) appears to have had skin penetration. An oval brown discoloration was within the hyperemic region of this wound, suggesting penetration and perhaps singeing. However, some wounds keep margins somewhat reddened (hyperemic) as the refrigeration in the morgue reoxygenates the areas that subject to a small loss of the superficial layer of the epidermis. The distance between the wounds was approximately 3.7 cm using the scale shown in Fig.11A.

Fig. 11. Wound evidence of the stun gun used in the victim's attack. (A) The posterior torso of the victim showing two small wounds on his right lateral mid-lumbar skin. (B) Enlargement of the area in the square in A; image was color adjusted (Photoshop/Image/Adjustments/Hue/Saturation) to show a halo of hyperemia about 10 cm from the wounds. (C) Additional enlargement of this wound area reveals the two wounds have different shapes. (D) Similar wounds were attributed to a stun gun in the1996 JonBenet Ramsey homicide case; images downloaded from the Internet via Google. (E) The Air Taser 34000 without its taser dart projection module; this Taser model ceased production in 1998 [26]. (F) The Air Taser 34000 face without its taser module showing its electrodes; the two electrodes are flat, copper or copper plated tabs (image from [27]). The right electrode (inset) was forcibly lifted, breaking away part of the electrode housing (note scratch marks), likely to achieve better skin contact, thus converting the taser into a stun gun. The electrode central distance between the two in this example was approximately 3.7 cm.

The difference between these wounds in Johnson (3.7 cm) and those of Ramsey (3.5 cm) appears due to the one electrode (the right one in Fig.11F) had been bent to 90 degrees in Johnson, increasing this distance by 2 mm. Evidence that an electrical current was applied via a stun gun to Johnson was the victim's clothing (3 shirts, Picture 005 [12]) and skin impedance reduced the electrical current to cause vasodilatation [24] generating a halo of hyperemia approximately 10 cm from the wounds (Fig. 11B). This halo remained at Johnson's death and although distinctive, was not noted in the autopsy report [2].

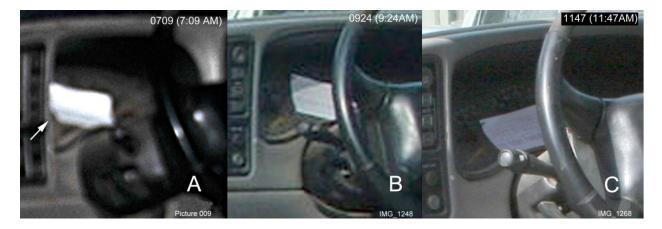
Figure 12 shows a 7.6 x 20.3 cm (3 X 5 inch) card on the instrument panel area of the victim's truck at three different times during the shooting scene processing. This is a hand-written love note (Fig. 13). Figure 12A, an image likely taken at 0609 (6:09 AM), shows the original position of the card on the instrument panel of the victim's truck. The victim did not place the card there simply because it was not in a stable position and there is a transfer stain on the card's top left corner (Fig. 13B). The card was also slightly bent (Fig. 12A, arrow).

**Fig. 12.** Images taken at different times of the victim's truck instrument panel with the love card (see Fig. 13). (A) Image taken at 0709 (7:09 AM); the time stamp is likely off by an hour would mean this image was taken at 0607 or within an hour of the victim's death. This image is out of focus. However, there is enough focus and resolution to show that the card is slightly bent at the arrow and positioned with its left side propped on the side of the instrument panel and its right lower corner on the steering column base bracket. Image sharpened by Photoshop: Filter/Sharpen/Unsharp Mask. (B) Image taken at 0924 (9:24 AM) and is enlarged by pixel addition (Photo: Image//Image Size/Pixel Dimensions – pixels added), but due to low resolution of the original image, is pixilated. The card is now fully on the instrument panel. It is in this card position that a secondary transfer bloodstain occurred (Fig. 12B). (C) By 1147 (11:47 AM), the card had shifted from the position shown in B.

An image taken at 0924 (9:24 AM) (Fig. 12B) shows that the card had been flattened and moved more onto the instrument panel. The position of the card at 1147 (11:47 AM) shows that it had moved again (Fig. 12C) although this time it likely shifted without human assistance.

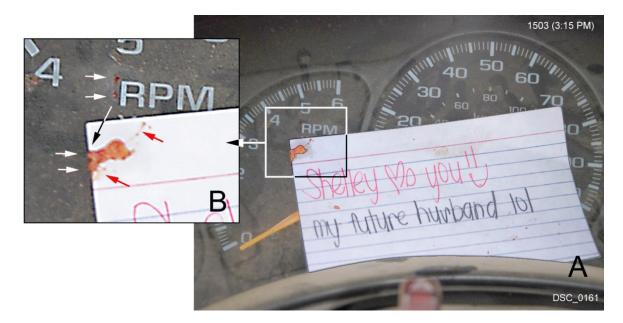
**Fig. 13.** (A) The instrument panel love card; the upper corner (in square) is a transfer bloodstain. (B) The enlargement (Image//Image Size/Pixel Dimensions – pixels added) of the edge of the card shows the transfer bloodstain, which had an edge accumulation of blood that secondarily transferred to the instrument surface (upper pair of white arrows); this occurred at the time the card attained the position shown in Fig. 12B. The pattern of the transfer corresponds to under-card edge blood accumulation on the card (at lower pair of white arrows). The bloodstains at the red arrows are associated with the main transfer but had just a small amount of blood transfer.

As of this writing, the origin of the card is unknown and who "Shelley" is (Fig. 13A). The bloodstain on the card (Fig. 13B) is a transfer, which likely occurred immediately after the shooting. The person who placed the card was contaminated with the victim's blood. Enough blood was associated with the transfer and was wet for there to be secondary transfer (Fig. 13B, at upper pair of white arrows). The poor focus of image Fig. 12A and the card's relative brightness makes the stain, likely present at this time, undetectable. The secondary bloodstain transfer to the instrument panel surface occurred when the card was in its second position (Fig. 12B).

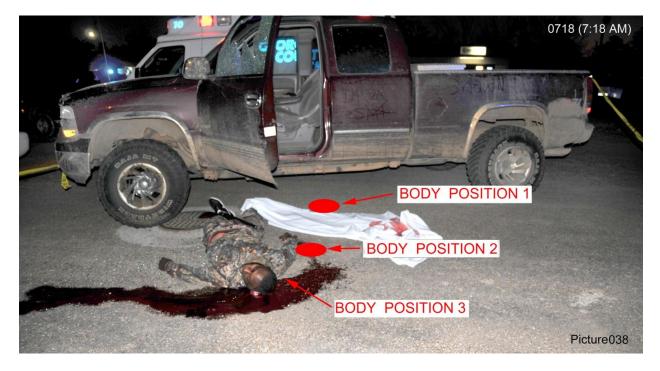
**Fig. 14.** Estimated locations of the staged body positions (center torso positions at red dots); the sheet used to cover the body is to the right of the body. Image likely taken at 6:18 AM (0618).

Following the discharge of the shotgun into the victim's head, he nearly vertically collapsed into position 1 (Fig. 14) with his head down, bloodstreams flowed onto his face (Figs. 9A and 9B) and his forehead momentarily on the pavement (Fig. 9A – dirt on his forehead). Transfer/wiped bloodstains were associated and under these bloodstreams (Figs. 9A and 9B), which indicates that the body was handled by at least one blood-contaminated assailant immediately after the shotgun discharge.

The moving of the body from position 1 to position 2 (Fig. 14) left a trail of blood (Fig. 7, at 1), which came from both the entrance wound and blood flow from the victim's mouth (Fig. 9A). At bloodstain 2 (Fig. 7) is a large stain that has spines and satellite spatter. This was created when the victim's head was elevated above the pavement and his head turned left spilling blood from the vessel-like wound (Fig. 1A) before placing the body down where additional bleeding from the wound added to the blood pool, which flowed west (Fig. 8). The body was moved again to its final position (Fig. 14, BODY POSITION 3) where the blood pool 2 was joined by the blood pool 3 (Fig. 8). The demarcation of the two blood pools is estimated in Fig. 8B. The victim's heart was beating for some time after he was shot.

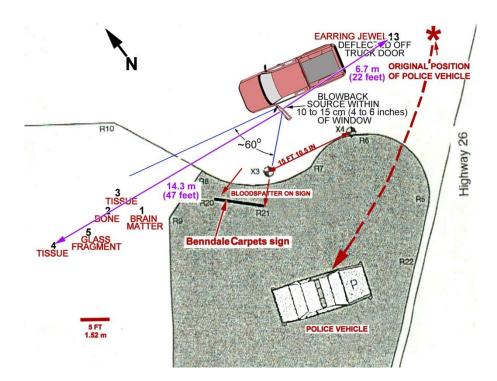
**Fig. 15.** Trajectory of the spattered tissue from blowback for the contact or near contact discharge of the 12 gauge shotgun to the victim's left head. Based on evidence items 1 through 5, which are pieces of tissue and a piece of glass and the bloodspatter on the Benndale Carpets sign is approximately 60 degrees from the truck's driver side door.

The 12 gauge shotgun discharge produced a massive blowback through the entrance/exit wound (Fig. 1A) where it sent tissue as much as 14.3 m (47 feet) from it (Fig. 15, item 4). The west border of the triangular area of tissue projection was marked by evidence item 3 (Fig. 15) and to the east border of the back spatter area (marked by the Benndale Carpets sign, Fig. 15) is about 60 degrees. When projecting back on the triangular area to the truck window, the blowback was consistent with a 10 to 15 cm (4 to 6 inches) source from the interior of the truck door window (Fig. 15). Tissues were projected through the iris-like window remnant and onto the remaining tempered glass fracture mosaic window (Fig. 3C). The shooter and his shotgun were also hit with blood and tissue blowback.

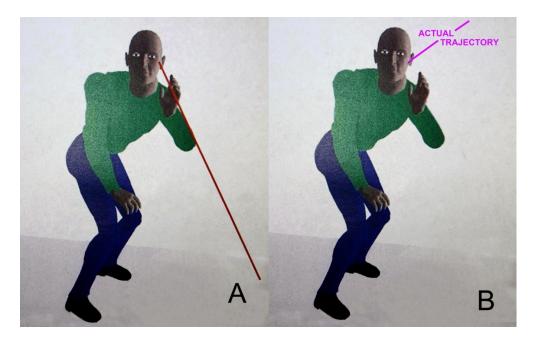
**Fig. 16.** (A) Graphic of the Billey Joe Johnson "accidental" death scenario presented to the George County Grand Jury, which showed an incorrect shot trajectory (red line). (B) The corrected graphic of the trajectory of the shot from the shogun discharge; the shot was from left to right and upward from the mouth or in terms of shotgun discharge origin, the trajectory of the near contact discharge was downward from the left ear to the mouth. Because the shot was penetrating, there was massive blowback.

The George County Grand Jury allegedly interviewed 30 witnesses and reviewed 65 exhibits [3]. Only one of these exhibits was available for this study, which was a summary graphic presented to the jury showing an incorrect trajectory of the alleged accidental discharge of the shotgun (Fig. 16A). The correct angle is shown in Fig. 16B.
