## Nose or Base Strike: Analysis of bullet orientation in a ricochet

Bryan Burnett

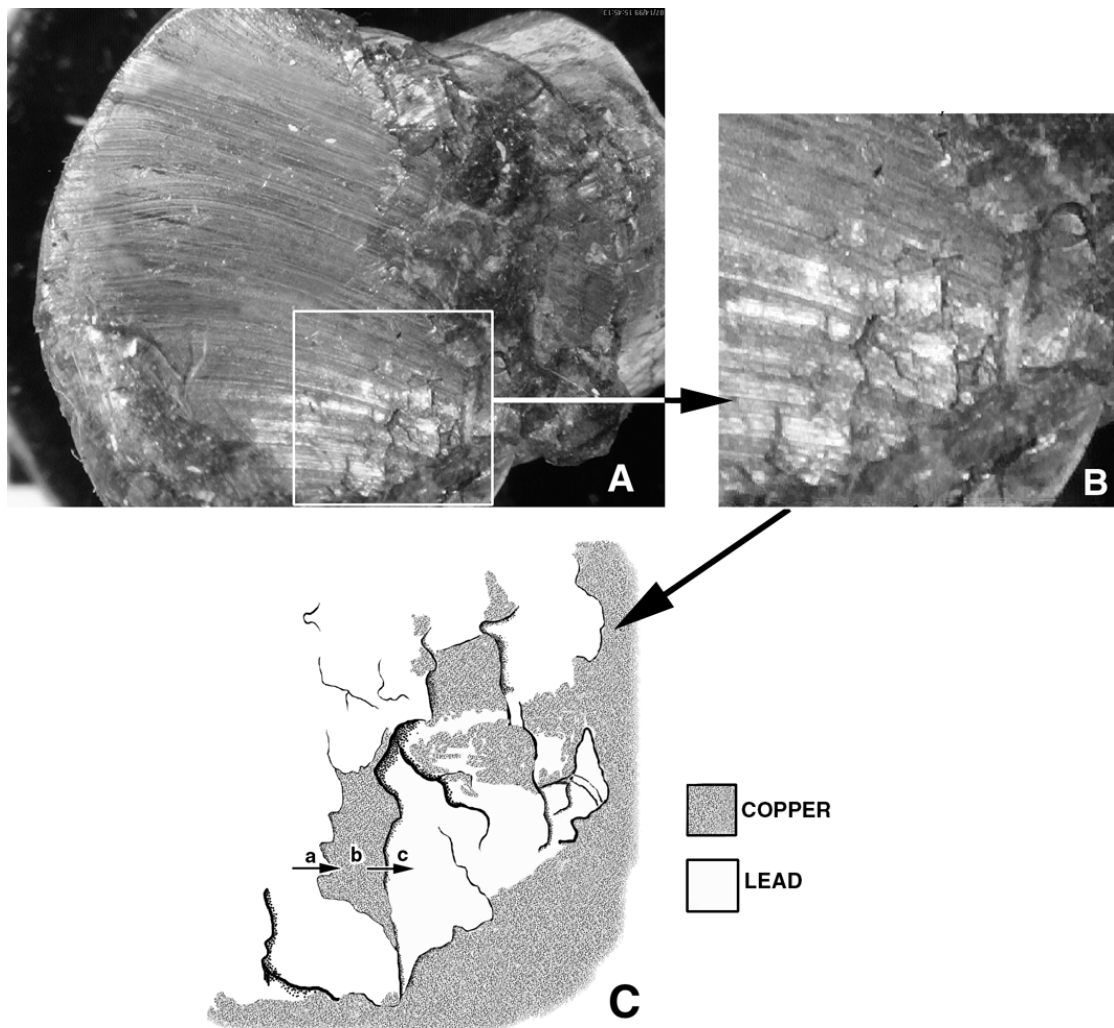
**Figure 1.** The questioned .22 bullet. A: The second impact area showing the region (box) of apparent lamina. B: An enlargement of the box area in A. C: Drawing of the region showing the distribution of copper (uniform stipple) from the .22 bullet coating.

Figure 1B is an enlargement of a portion of the second strike area shown on the victim's bullet in Fig. 1A. In this region of the victim's bullet are a series of apparent overlapping laminae. The surface of each lamina has tool-like marks and in this sequence of the laminal surfaces are remnants of the copper coating from the .22 bullet surface. Figure 1C is a drawing of this area which maps the distribution of copper (uniform stippled areas). In one part of this area, the overlapping lamina-like surfaces are particularly well defined. Copper alternates with lead on the laminal surfaces. Arrows in Fig. 1C indicate the direction of the overlap. The surface of layer "a," overlaps surface "b." The surface area of "b" is copper coated. Surface "b" overlaps surface "c." The laminal surfaces marked "a" and "c" do not have copper associated.

The presence of laminal features on the margin of the strike zone of a bullet is an indicator the direction of that strike. The questioned .22 bullet likely struck near the nose first when the second impact zone was created.

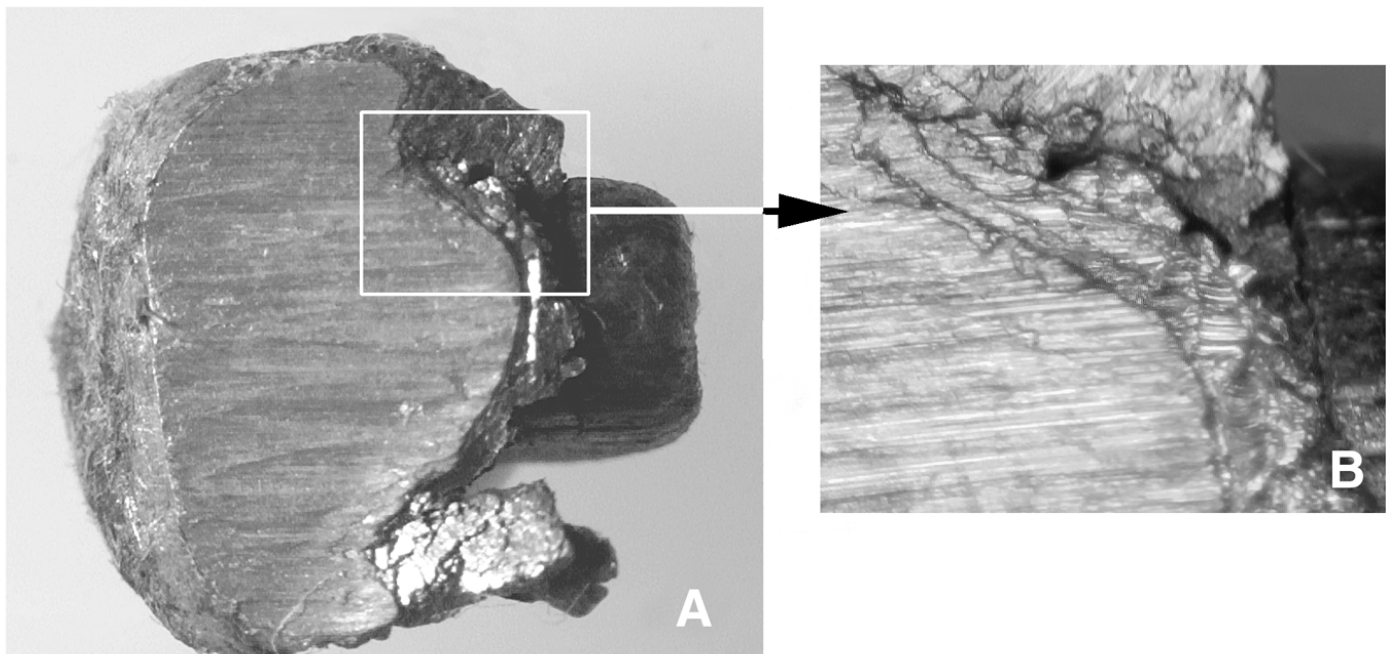
A number of .22 bullets that were mushroomed by being fired through window glass (and caught in a cotton box) were clamped on their bases in a Visegrip™ pliers and struck, nose leading, at approximately 30° angle on a smooth concrete surface. The result of one of these simulated bullet strikes is shown in Fig. 2. The bullet (Fig. 2A) showed laminal structures on the trailing edge of the impact zone on the bullet (Fig. 2B). The front margin of the strike area (Fig. 2A) is uniform with no laminae.

**Figure 2.** Test bullet that was hit at approximately a 30° angle on a concrete surface. A: The .22 bullet showing a region of laminal formation (box). B: An enlargement of the boxed area on Fig. 2A showing the distinctive laminae on the trailing edge of the strike zone.

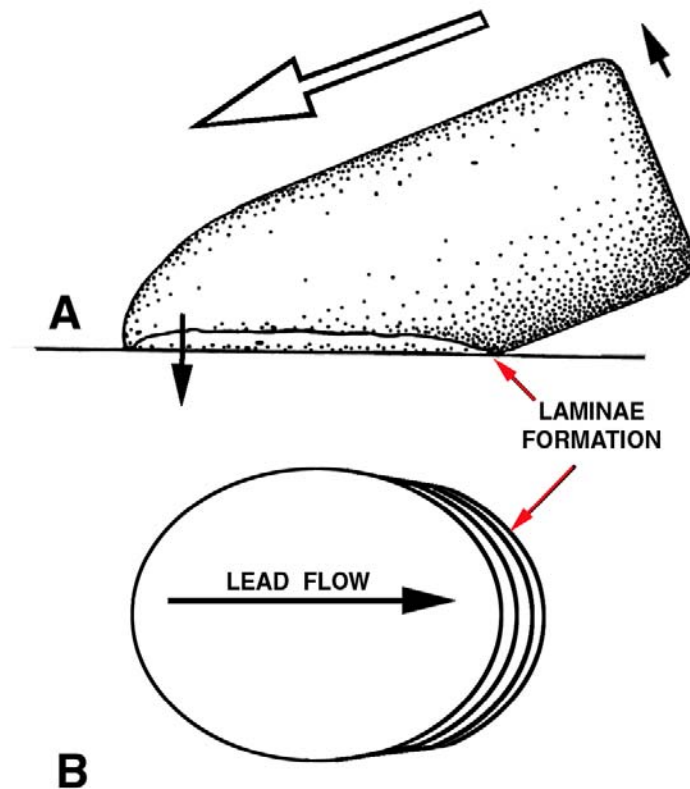
The formation of trailing-edge laminae on the bullet is likely associated with a lead bullet ricochet. As shown by diagram (Fig. 3A), the bullet hit the object at an angle. The forward force of the bullet impact tends to push the bullet's nose into the object's surface with the base of the bullet rotating away from that object. The lead in contact with the strike surface flows toward the base of the bullet as it engages that surface. Small wavelets of lead that are apparently created during this process flow in the opposite direction of the bullet travel while the bullet engages the surface. As the bullet base rotates on this surface more wavelets are created. Thus, the trailing edge of the bullet impact area is left with the impression of laminae as shown in Fig. 2B.

**Figure 3.** A: Diagram of a lead bullet in the process of a ricochet strike on a surface. White arrow: the direction of the strike. Black arrows: direction of rotation of the bullet. B: Diagram of the bullet's contact surface showing the probable lead flow during contact with a surface.
