# **A Staged Suicide: The Billey Joe Johnson Homicide**

**Bryan R. Burnett <sup>a\*</sup> Cataldo Raffino <sup>b</sup> John D. Sabow <sup>c</sup>**

## **ABSTRACT**

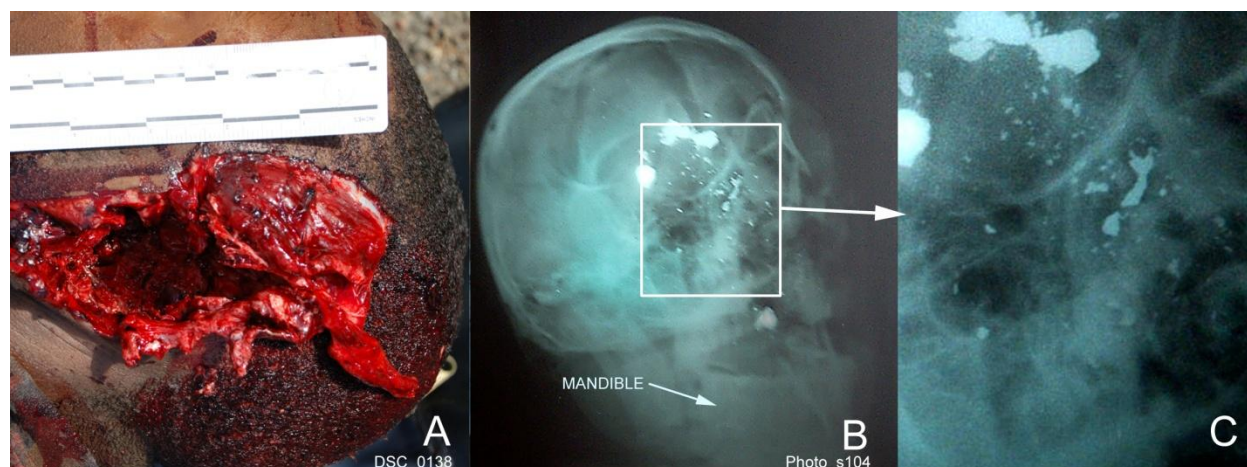
**Fig. 1.** (A) Image of the left side of the victim's head showing the massive defect caused by the 12 gauge shotgun's discharge; the autopsy report determined this is the entrance wound [2]. (B) LL projection X-ray of the victim's head shows lead projectiles; one of the shotgun pellets is at the victim's upper jaw, overlapping his teeth. Image enhanced by Image/Adjustments/Levels routine. (C) Enlargement of the area within the rectangle in B showing numerous fine particles from lead shot fragmentation.

Multiple lead pellets and fragments within the victim's head (Figs. 1B and 1C) were shown in a LL projection X-ray image. The shotgun discharge was not intraoral, although the entrance/exit wound (Fig. 1A) appears similar to an exit wound for an intraoral shotgun discharge [15].

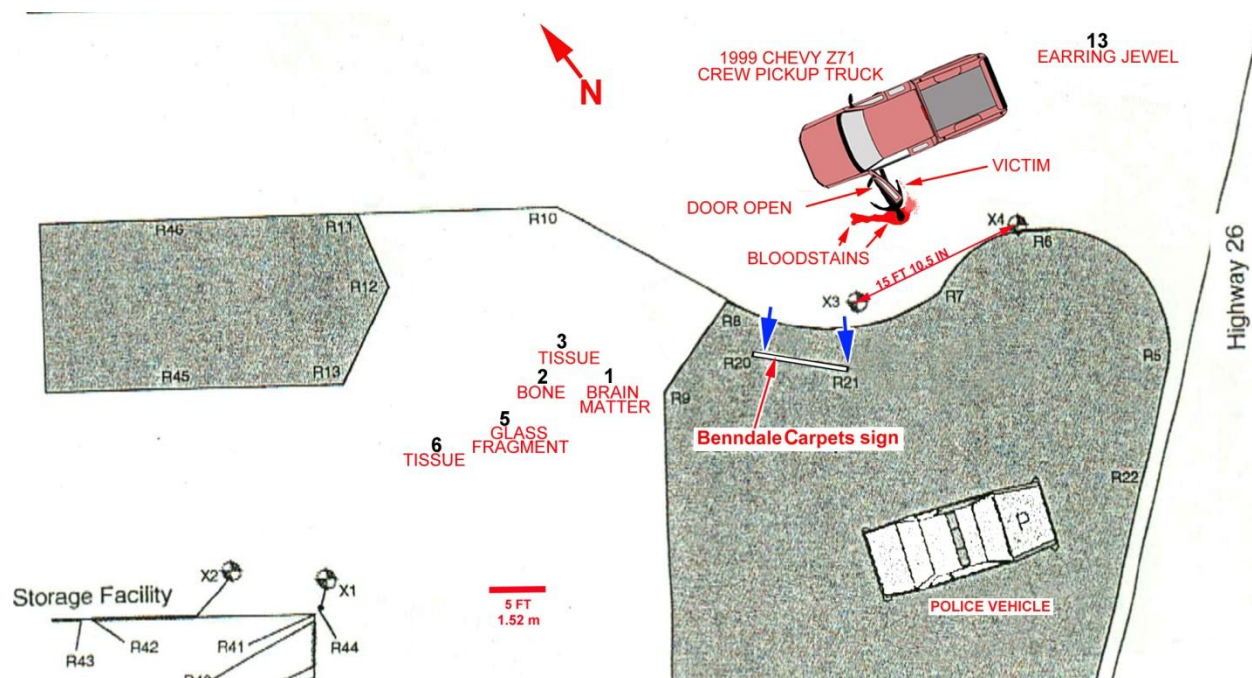
Figure 2 is a graphic to scale of the shooting scene, which was revised from the poor photocopy of the graphic of the scene provided in the discovery. The locations of evidence items 1 through 5 and 13 are shown.

**Fig. 2.** The shooting scene drawing provided in the discovery; the victim, truck and bloodstains graphics were redone due to poor copy quality. The truck's driver side door was open and the victim was lying under it. The red graphics/lettering by the author and the scale of the scene drawing was verified. Blue arrows indicate the locations on the Benndale Carpets sign that was hit with blood/tissue spatter.

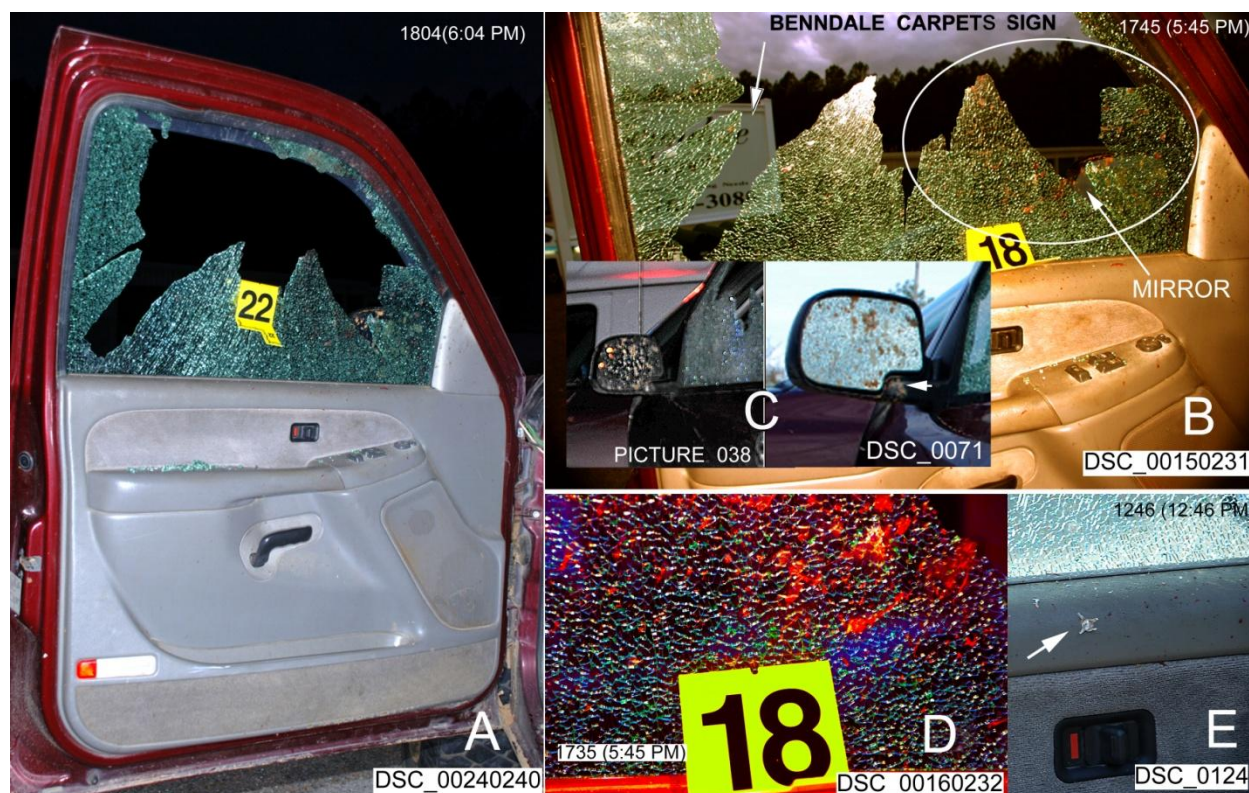
Figure 3A shows the interior driver side door of Johnson's truck. Blowback is evidenced by blood and tissue coating a part of the window's remaining tempered glass fracture mosaic (Fig. 3B circled area). Tissue debris also coated the door mirror (Fig. 3C) which is added evidence that the victim's head was quite close to the window at blowback. A close-up image of the remaining window shows the extent of the blood and tissue covering it (Fig. 3D lower left circled area of Fig. 3B).

**Fig. 3.** (A) The driver side interior door of the victim's truck showing the window's tempered glass fracture mosaic. (B) The image of the interior door window has been color adjusted using Photoshop: Image/Adjustments/Color Balance to show extensive blood/tissue spattering on the window. (C) Two images of the driver side door mirror that shows the extensive tissue spattering. (D) Close-up of the window where red is enhanced in Photoshop: Image/Adjustments/Color Balance followed by Vibrance to show a coating of blood and tissue at the lower left part of the window circled in B. The tempered glass mosaic near evidence marker 18 showing extensive spattering of tissue; Photoshop: Image/Adjustments/Color Balance followed by Vibrance. (E) The victim's earring base attached to the windowsill at the arrow. Only small spatters are on the windowsill.

The victim's earring post was attached to the lower windowsill (Fig. 3E, arrow) and its jewel separated and deflected off the sill to the location indicated in Fig. 2 (evidence item 13) due to the shotgun blast. There was no blood association with the surface of the door sill surrounding the earring post, which indicates that the earring was blown from the victim's pinna by the shotgun blast, not by blowback. The distance from the truck's driver side door to the earring jewel was approximately 6.7 m (22 feet). The earring jewel separated from its post in the shotgun blast, bounced off the door windowsill to the pavement at the rear of the victim's truck (Fig. 2, item 13). The left side of the victim's head was estimated to be 10 to 15 cm (4 to 6 inches) from the door window for this to occur.

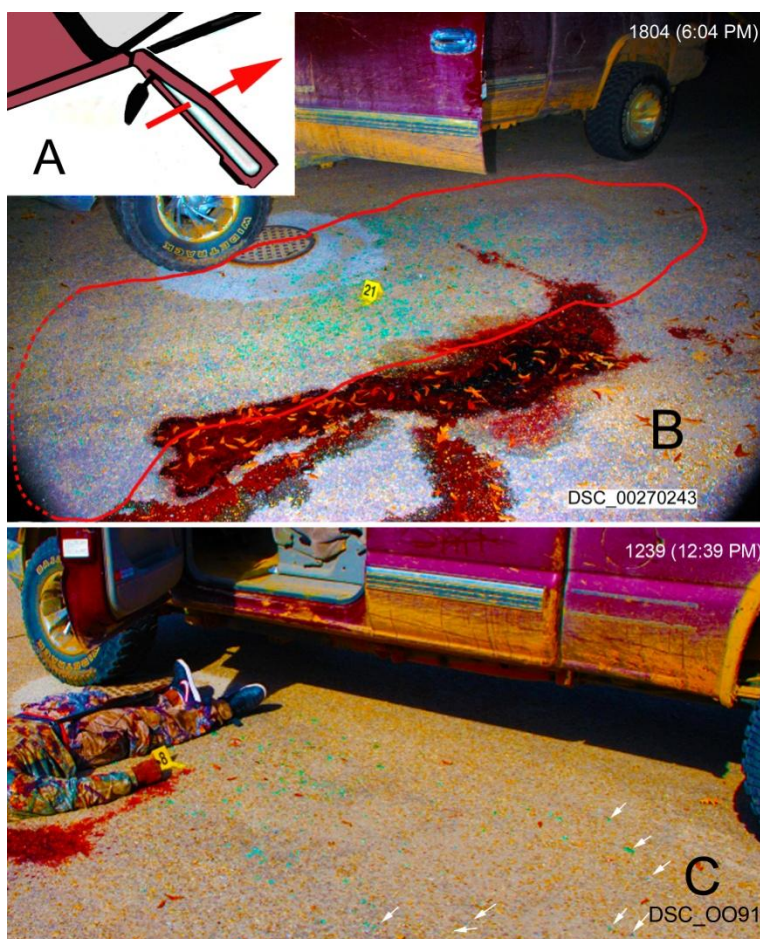
**Fig. 4.** (A) Graphic showing the direction of the initial breakage from the driver side door window that projected glass shards toward the rear of the truck. (B) Distribution of glass shards on the pavement with the body removed (time stamp 1804 (6:04 PM)); the glass shards on the pavement were from the initial breakage with shard projection to the rear tire. The red outlined area is the approximate demarcation of the glass shards on the pavement. The red line is dotted on the left due to the glass shards projection further than shown in the image. Adjustment by Photoshop: Image/Adjustments/Vibrance tool accentuates the glass shards (blue) on the pavement. (C) Distribution of glass shards on the pavement (time stamp 1239 (12:39 PM)); the glass shards on the pavement extend to the rear tire. Adjustment by Photoshop: Image/Adjustments/Vibrance tool accentuated the glass shards (blue) on the pavement. Due to the different ambient light from image B, not all the glass shards are color accentuated by this Photoshop application.

Glass shards were deposited onto the pavement from the driver side window at three different times. The first occurred from the initial breakage/fracturing where the breaking force was to the outside of the open door (Fig. 4A) and had sufficient force to project glass shards as far as the rear tire of the truck (Fig. 4B and 4C). Only one glass shard was found on the victim's clothing (Fig. 6A, at arrow) and none on his left shoe (Fig. 6A, insert). If the victim was standing within the area of the shard projection at breakage, the area of glass shards on the pavement without a void, and the lack of numerous glass shards on his clothing indicate the victim was not within the glass shard projection.

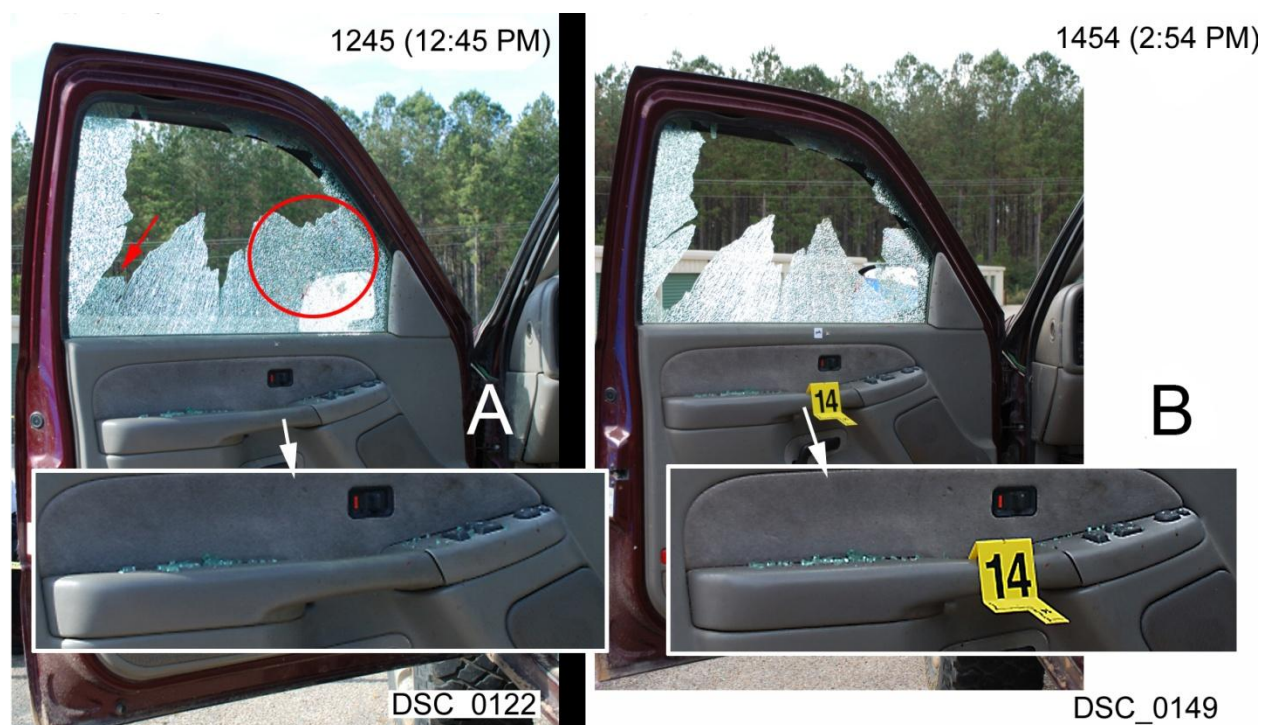
**Fig. 5.** (A) The appearance of the truck window from the time of initial breakage before the shooting to early afternoon (image time stamp is 1245 (12:45 PM)); the circled area has the spattered blood and tissue from blowback as well as loss of glass (see B). Red arrow points to additional glass loss shown in B. Backlighting prevents seeing blood and tissue coating on the window in this image (see Fig. 3C). Inset: enlargement of armrest showing accumulation of glass shards from the initial window break. (B) Image shows collapse of some of the glass from the window, which occurred between 1245 (12:45 PM) and 1454 (2:54 PM); the inset of the armrest glass shards shows little change from A. This indicates that the additional collapse of the tempered fracture glass mosaic was mainly toward the exterior side of the open door.

Between 1246 (12:46 PM) and 1454 (2:54 PM) a portion of the fractured tempered glass still in place (Fig. 5C) collapsed (Fig. 5D) onto the pavement (third deposition). This deposition was mostly exterior to the open truck door and away from the body. Some of the glass fell on the armrest on the interior side of the door (compare the armrest images (insets) Figs. 5C to 5D).

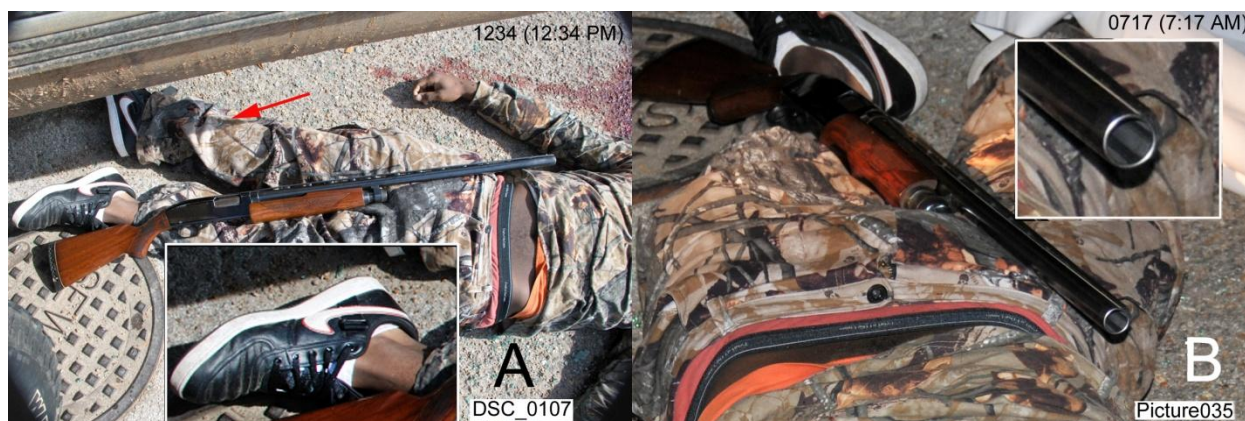
**Fig. 6.** The Sears M200 12 gauge shotgun. (A) Despite being identified as the source of the fatal wound to the victim, the shotgun had no associated blood or tissue; inset: enlargement of the victim's left shoe showing no associated glass shards. Arrow: points to the single glass shard on victim's pant leg. (B) Another view of the shotgun; tissue and blood would be expected to cover the victim's shotgun if this was the shotgun used in his death. Inset: the bore of the shotgun at the muzzle shows no blood or tissue.

The shotgun barrel should have been hit with blood due to the massive blowback, brain tissue, etc., which usually occurs in either suicide or homicide scenarios by a near contact shotgun discharge to the head [15]. The exterior of the shotgun showed no tissue contamination (Figs. 6A and 6B). No tissue was within the bore of the shotgun (Fig. 6B, inset). Another shotgun discharged into the victim's head.

The 12 gauge shotgun has the strongest recoil of most firearms [19]. The trajectory of the pellets in the head [2] and the blowback occurring near the truck door window (Fig. 3) would have the shotgun elevated off the ground and unsupported in the suicide scenario. The close proximity of the victim's head to the door window and the angle at the shotgun's discharge would mean more than half the shotgun would be on the exterior side of the door window. In the suicide scenario, the victim somehow managed to reach the trigger on the exterior side of the window after breaking it with the shotgun stock. Upon the discharge in this scenario, the unsupported shotgun recoil would propel it through the window, away from the victim. The victim's shotgun was on top of his body (Fig. 6).

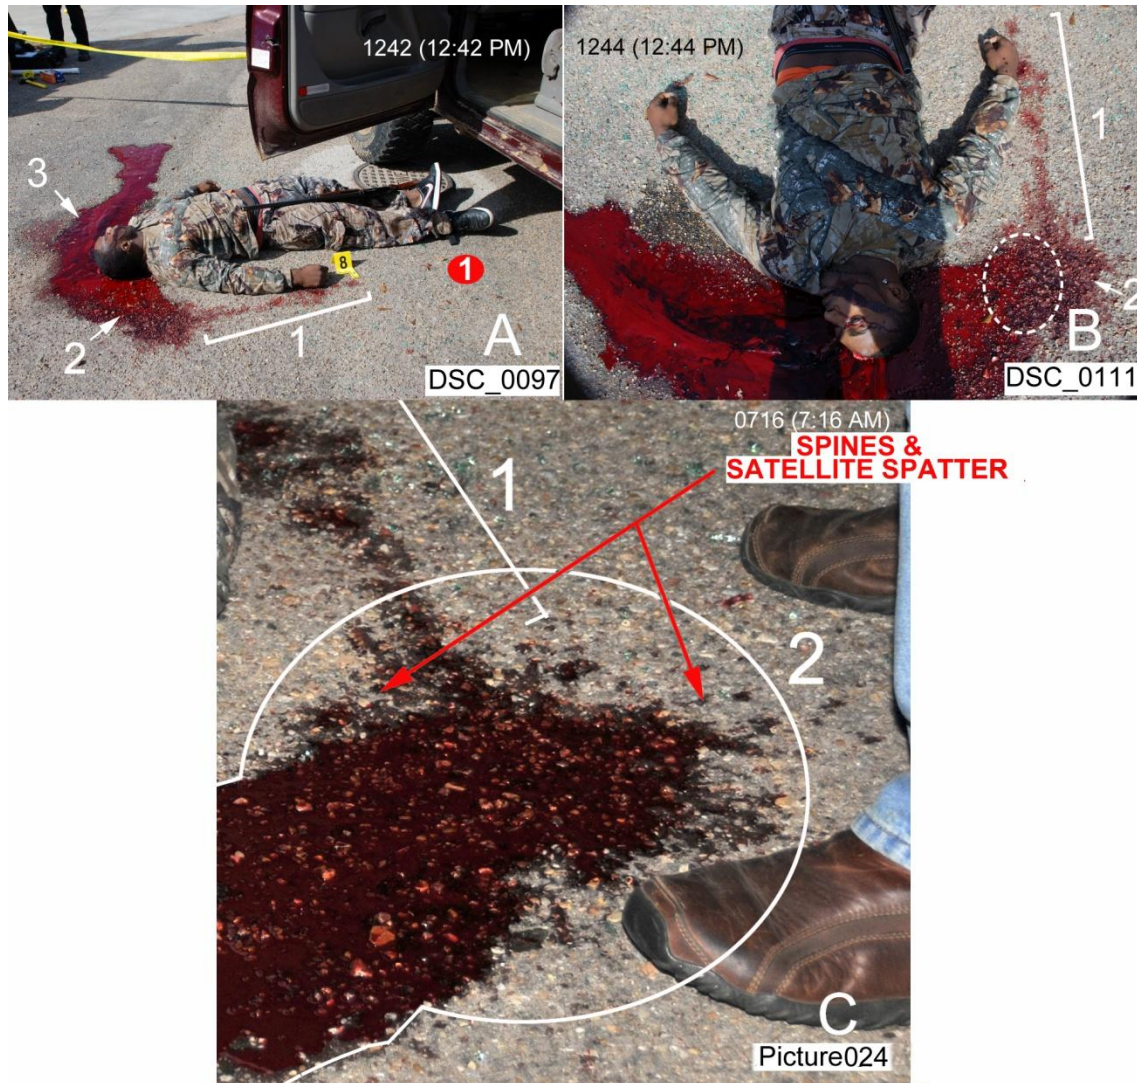
**Fig. 7.** Pavement bloodstains; stain numbers 2 and 3 correspond to the numbered body positions. The body is in position 3 in these images. (A) Image of the body and associated stains; blood trail 1 documents that the body was moved from the position where he collapsed (at the red dot) following the shotgun discharge. Blood trail 1 goes from the stain just in front of the right hand to the larger stain 2. Bloodstain 3 originated from the body at position 3 as shown. (B) As in A, but image was taken with the photographer standing near the victim's head with his shadow over the body; the dashed line oval is the probable location of the victim's head in body position 2. (C) Image of stains 1 and 2; a spattering event (splash pattern) occurred in circled area of stain 2 when the head was elevated above the pavement prior to setting the body down in position 2. The blood came from the massive, vessel-like head wound (Fig. 1A) when the head was turned to the left while elevated above the pavement, poring blood onto the pavement which created a pool with the spines and satellite spatter due to splashing. Image probably taken at 0616.

The victim almost vertically collapsed after the shotgun discharge. The bloodstains labeled 1 in Fig. 7 show a trail, which originated from the initial victim collapse location (at the red dot in Fig. 7A). The trail leads to a blood pool. Blood had quickly filled the massive vessel-like head

wound and creating a splash pattern (Fig. 1A) when the victim's head turned left while he was elevated above the pavement. Blood spilled from the vessel-like wound and into the developing pool, the blood-into-blood splashing created spines and satellite spatter (Fig. 7C).

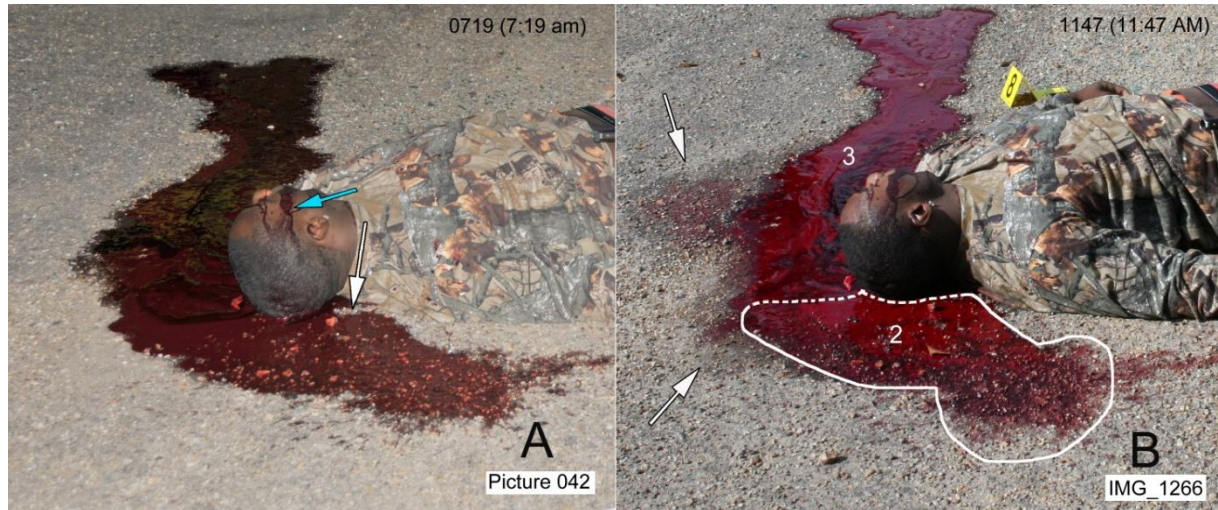
**Fig. 8.** Bloodstains 2 and 3 and the result of covering the body with a sheet. (A) Image taken at 0719 (likely ~ 0619 (6:19 AM)) showing a gap in the stain near the victim's neck (at white arrow) which was not present in the images taken later. Blood flow from the victim's mouth occurred when his head was facing up or to the right (at blue arrow). (B) The stain gap at the arrow in A provides demarcation estimation between the blood deposited when the body was at position 2 (Fig. 7) and the final position 3 of the body. Bloodstain 3 originated from the final position of the body. The white outline is the estimated extent of the stain when the body was at position 2 to where the blood flow from body position 3 added to the stain from the victim at position 2 (estimated at dashed line). Arrows point to the stains caused by blood and serum wicking by the cloth sheet placed over the body.

A demarcation between the bloodstain pool deposited when the body was on the pavement at position 2 and the final position can be seen in Fig. 8A at white arrow. The blue arrow in Fig. 8A points to blood flow from the mouth when the head was face up or turned to the right. The extent of stain 2 is outlined in Fig. 8B. The dashed line approximates where bloodstain 2 merged with stain 3.

The consequence of the sheet covering the body is a modification of the bloodstain. Figure 8A is an image of the unmodified bloodstain. Figure 8B, taken more than four hours later, shows the result of the placing a sheet over the body. Blood and serum wicked by the body-covering sheet created blood/serum stains (Fig. 8B at arrows) from the large blood pool.

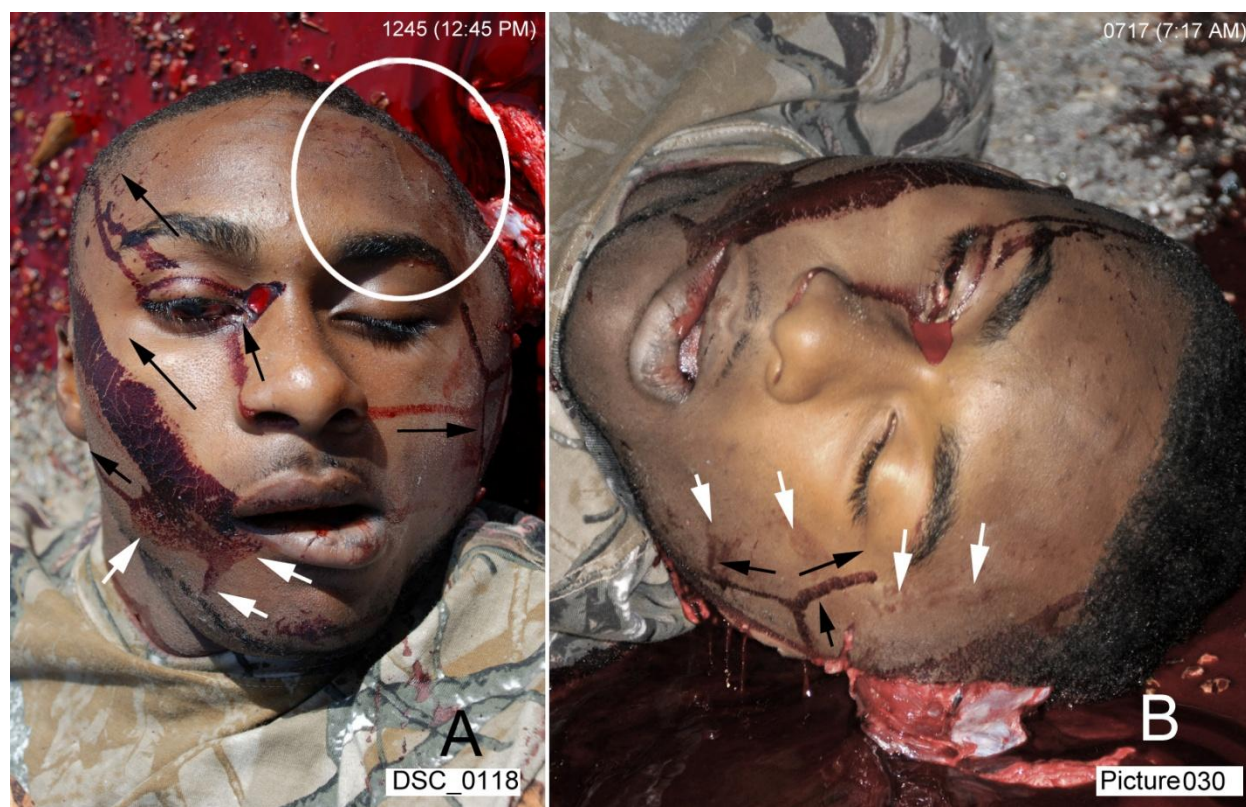
**Fig. 9.** (A) Bloodstains on the victim's face; black arrows indicate the direction of blood flow when each stain was created. The head had changed positions from the time of the shotgun discharge to the position shown in the scene images. The victim's forehead came in contact with dirt (circled). The white arrows point to a blood wipe that occurred immediately after the shotgun discharge by an assailant's hand when the body was being moved. (B) Transfer stains (white arrows): the time stamp on this image was likely 0617 (6:17 AM) or within one hour of the shooting; the bloodstream from the victim's left nostril shown in A had not yet occurred. Three changes in the body position occurred, which are reflected by the Y-shaped stain. These streams could not have occurred in the found body position. Black arrows show the direction of the blood flow. Transfer stains (at white arrows) occurred before the "Y" arms of the bloodstream. This image was color adjusted by Photoshop/ Image/Adjustments/Hue-Saturation.

The bloodstains on the face of the victim (Fig. 9) provide additional evidence of the movement of the body immediately after the fatal shot. Dirt on the victim's forehead (Fig. 9A, circled area) indicates that his left forehead came into contact with the pavement. The black arrows in Fig. 9A show blood flow directions. The stains on the victim's right face (Fig. 9B) show his head, face down) was on pavement for a short time. This blood, which originated from his mouth,

A blood wipe was on the victim's face (Fig. 9A, white arrows). Its dried appearance, like the large blood flow from the victim's mouth to his right pinna, indicates that these two stains occurred within a short time, likely seconds, of each other. The victim's head was initially near the evidence marker 8 in Fig. 7A, immediately following the shotgun discharge.

The Y-shaped blood flow on the victim's left face (Fig. 9B), which originated from the shotgun wound, indicates changes in the head positions occurred within seconds following the wounding. The base of the Y stain (Fig. 9B) shows that the victim's head was face down immediately after wounding and his forehead likely contacted the pavement. The head position momentarily became vertical (the left arm of the Y-shape stain), which was followed by the head angle changing to a third position (the right arm of the Y-shaped stain). The latter blood flow was approximately at the same angle as the blood flow from the victim's mouth on his right face (Fig. 9A).

Before the creation of the two arms of the Y-shaped bloodstain, multiple transfer stains (Fig. 9B, white arrows) are on the victim's left face, under the two arms of the Y-shaped stain. The victim's head/body was manipulated immediately after the shotgun discharge by blood-contaminated hands.

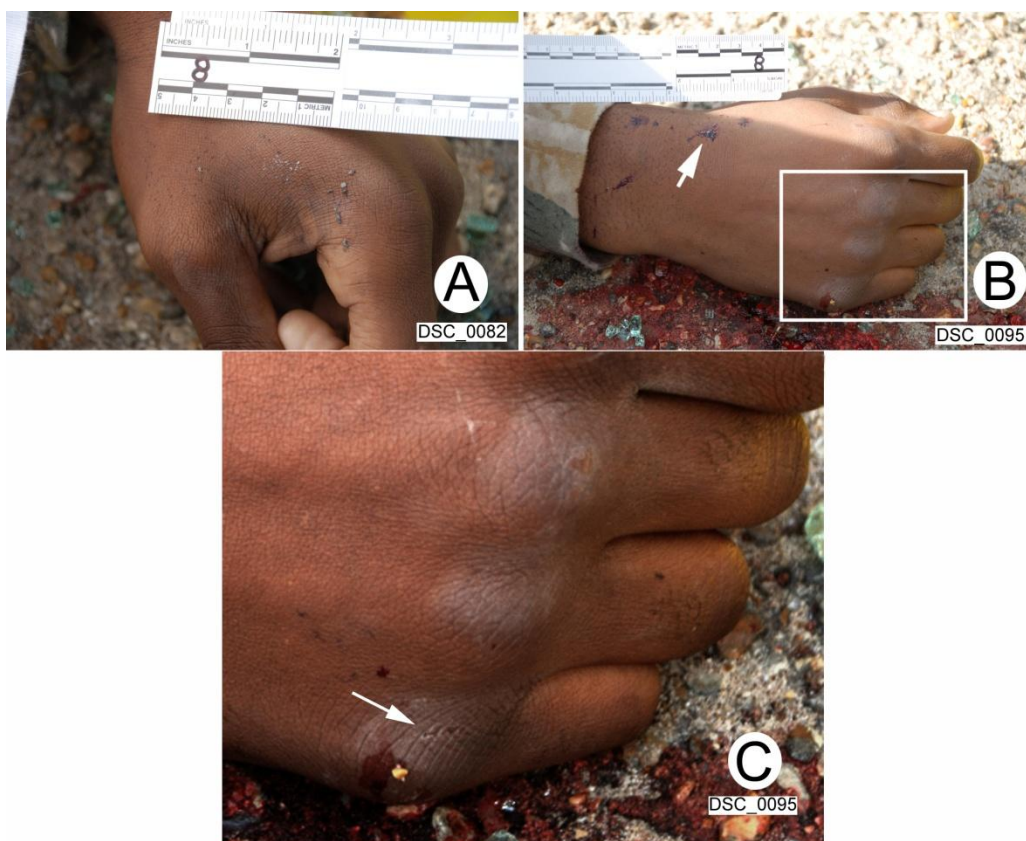
**Fig. 10.** (A) Left hand of the victim; the hand was in contact with the road pavement where it picked up dirt. (B) Right hand of the victim; the bloodstain at arrow has dirt associated; the outline area enlarged in C. Arrow points to road dirt associated with bloodspatter. (C) An enlargement of the outlined area in B showing the victim's knuckles were abraded; a small amount of skin was more deeply abraded at the arrow.

The victim's hands had dirt on them (Figs. 10A and 10B) indicating that these surfaces had been in contact with the pavement before body position 3. The right hand knuckles (Fig. 10C) also had abrasions, which were not reported in the autopsy report [2]. The victim appeared to have been punching at his assailants before his death although he could have obtained these abrasions in a high school football game two days earlier. But an image of the victim showed he was wearing gloves at a football game [20].

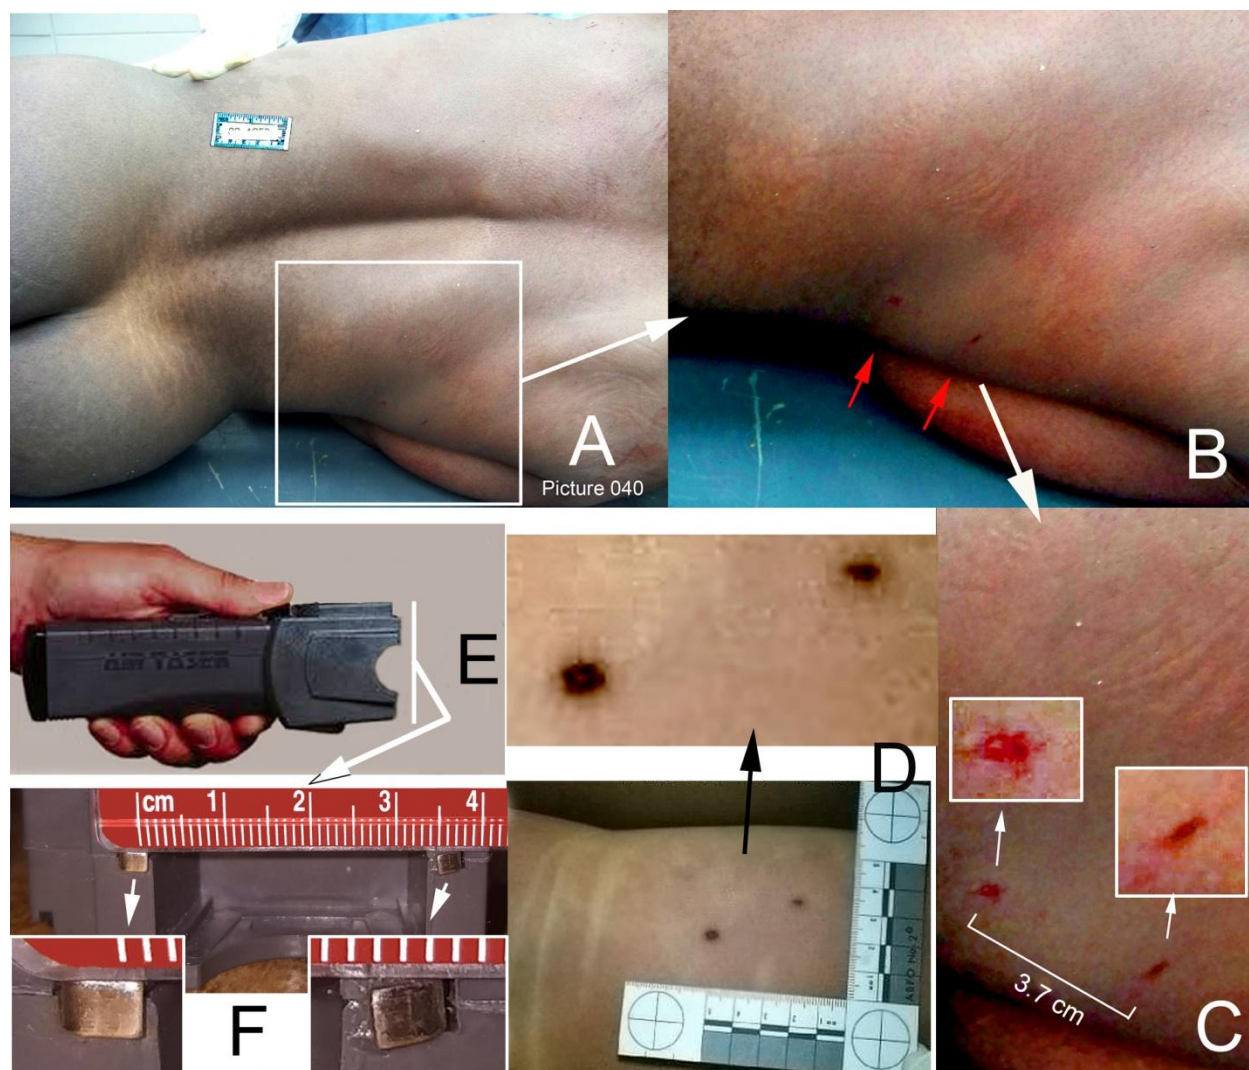
Two small wounds were on the victim's right lateral mid-lumbar region (Fig. 11A and Fig. 11B at red arrows). Notable is a halo of hyperemia approximately 10 cm from the wounds (Fig. 11B). The inferior wound (Fig. 11C, left) appears superficial, dispersed and roughly square. The superior wound (Fig. 11C, right) appears to have had skin penetration. An oval brown discoloration was within the hyperemic region of this wound, suggesting penetration and perhaps singeing. However, some wounds keep margins somewhat reddened (hyperemic) as the refrigeration in the morgue reoxygenates the areas that subject to a small loss of the superficial layer of the epidermis. The distance between the wounds was approximately 3.7 cm using the scale shown in Fig. 11A.

Fig. 11. Wound evidence of the stun gun used in the victim's attack. (A) The posterior torso of the victim showing two small wounds on his right lateral mid-lumbar skin. (B) Enlargement of the area in the square in A; image was color adjusted (Photoshop/Image/Adjustments/Hue/Saturation) to show a halo of hyperemia about 10 cm from the wounds. (C) Additional enlargement of this wound area reveals the two wounds have different shapes. (D) Similar wounds were attributed to a stun gun in the 1996 JonBenet Ramsey homicide case; images downloaded from the Internet via Google. (E) The Air Taser 34000 without its taser dart projection module; this Taser model ceased production in 1998 [26]. (F) The Air Taser 34000 face without its taser module showing its electrodes; the two electrodes are flat, copper or copper plated tabs (image from [27]). The right electrode (inset) was forcibly lifted, breaking away part of the electrode housing (note scratch marks), likely to achieve better skin contact, thus converting the taser into a stun gun. The electrode central distance between the two in this example was approximately 3.7 cm.

The difference between these wounds in Johnson (3.7 cm) and those of Ramsey (3.5 cm) appears due to the one electrode (the right one in Fig. 11F) had been bent to 90 degrees in Johnson, increasing this distance by 2 mm. Evidence that an electrical current was applied via a stun gun to Johnson was the victim's clothing (3 shirts, Picture 005 [12]) and skin impedance reduced the electrical current to cause vasodilatation [24] generating a halo of hyperemia approximately 10 cm from the wounds (Fig. 11B). This halo remained at Johnson's death and although distinctive, was not noted in the autopsy report [2].

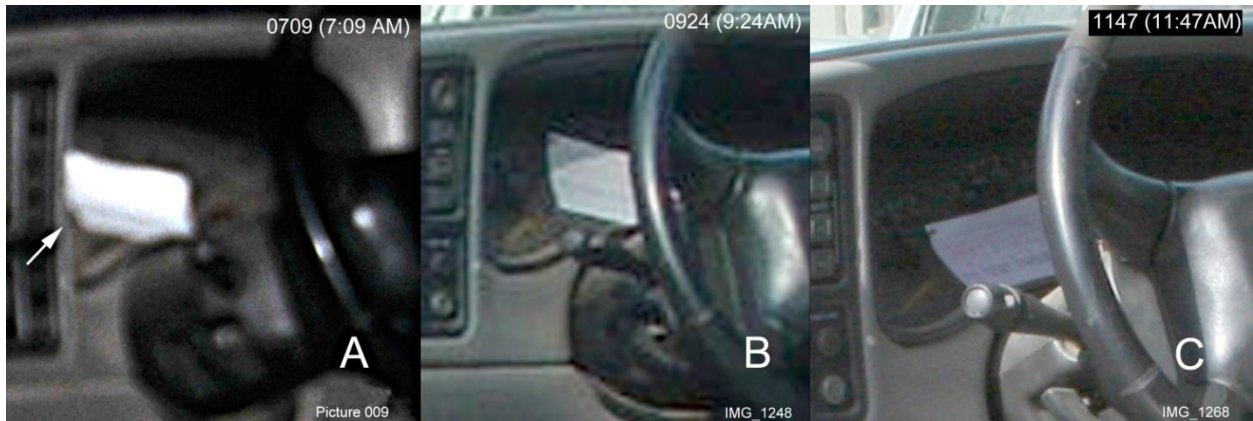
Figure 12 shows a 7.6 x 20.3 cm (3 X 5 inch) card on the instrument panel area of the victim's truck at three different times during the shooting scene processing. This is a hand-written love note (Fig. 13). Figure 12A, an image likely taken at 0609 (6:09 AM), shows the original position of the card on the instrument panel of the victim's truck. The victim did not place the card there simply because it was not in a stable position and there is a transfer stain on the card's top left corner (Fig. 13B). The card was also slightly bent (Fig. 12A, arrow).

**Fig. 12.** Images taken at different times of the victim's truck instrument panel with the love card (see Fig. 13). (A) Image taken at 0709 (7:09 AM); the time stamp is likely off by an hour would mean this image was taken at 0607 or within an hour of the victim's death. This image is out of focus. However, there is enough focus and resolution to show that the card is slightly bent at the arrow and positioned with its left side propped on the side of the instrument panel and its right lower corner on the steering column base bracket. Image sharpened by Photoshop: Filter/Sharpen/Unsharp Mask. (B) Image taken at 0924 (9:24 AM) and is enlarged by pixel addition (Photo: Image/Image Size/Pixel Dimensions – pixels added), but due to low resolution of the original image, is pixilated. The card is now fully on the instrument panel. It is in this card position that a secondary transfer bloodstain occurred (Fig. 12B). (C) By 1147 (11:47 AM), the card had shifted from the position shown in B.

An image taken at 0924 (9:24 AM) (Fig. 12B) shows that the card had been flattened and moved more onto the instrument panel. The position of the card at 1147 (11:47 AM) shows that it had moved again (Fig. 12C) although this time it likely shifted without human assistance.

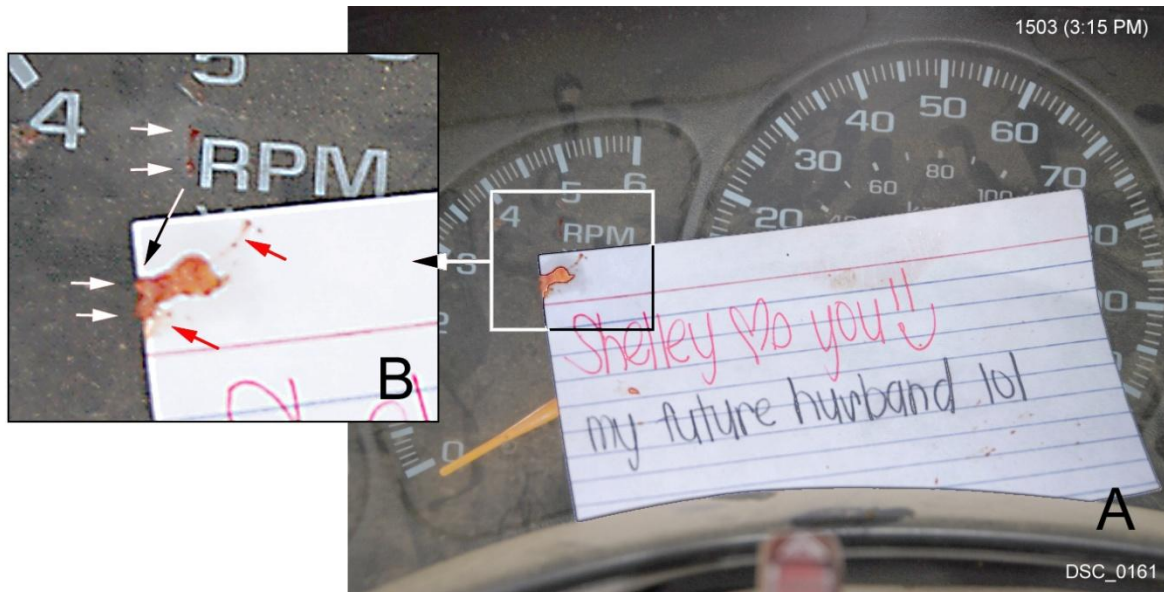
**Fig. 13.** (A) The instrument panel love card; the upper corner (in square) is a transfer bloodstain. (B) The enlargement (Image/Image Size/Pixel Dimensions – pixels added) of the edge of the card shows the transfer bloodstain, which had an edge accumulation of blood that secondarily transferred to the instrument surface (upper pair of white arrows); this occurred at the time the card attained the position shown in Fig. 12B. The pattern of the transfer corresponds to under-card edge blood accumulation on the card (at lower pair of white arrows). The bloodstains at the red arrows are associated with the main transfer but had just a small amount of blood transfer.

As of this writing, the origin of the card is unknown and who “Shelley” is (Fig. 13A). The bloodstain on the card (Fig. 13B) is a transfer, which likely occurred immediately after the shooting. The person who placed the card was contaminated with the victim’s blood. Enough blood was associated with the transfer and was wet for there to be secondary transfer (Fig. 13B, at upper pair of white arrows). The poor focus of image Fig. 12A and the card’s relative brightness makes the stain, likely present at this time, undetectable. The secondary bloodstain transfer to the instrument panel surface occurred when the card was in its second position (Fig. 12B).

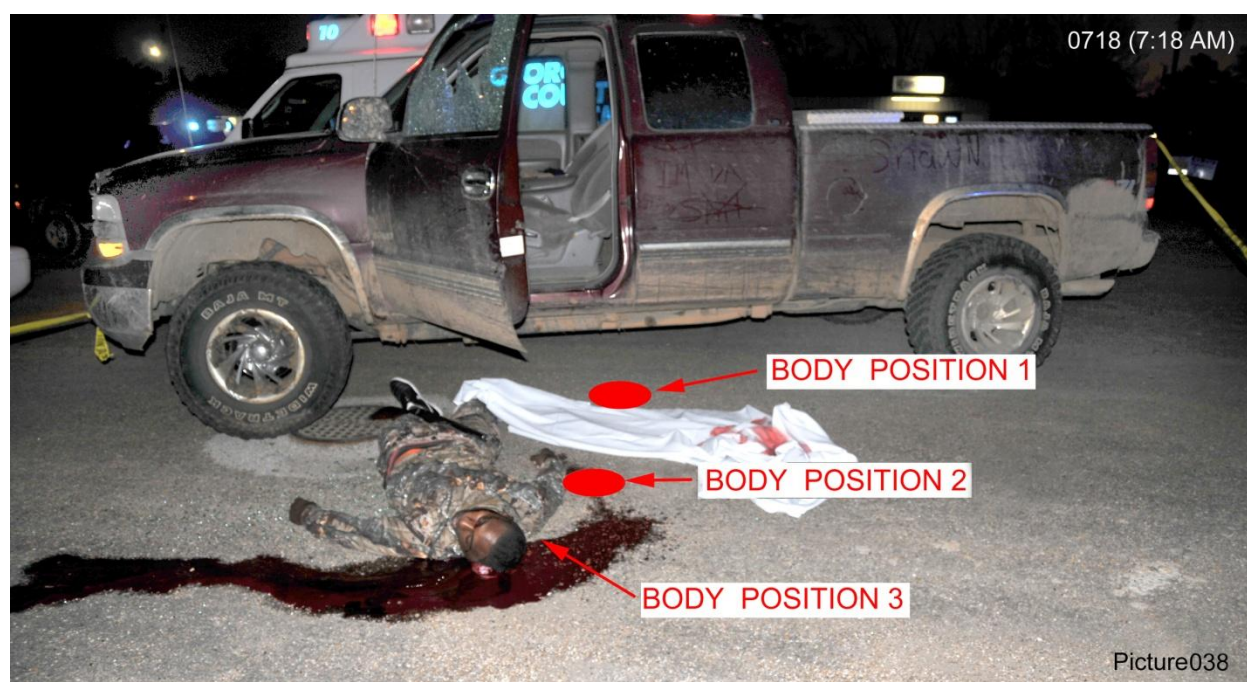
**Fig. 14.** Estimated locations of the staged body positions (center torso positions at red dots); the sheet used to cover the body is to the right of the body. Image likely taken at 6:18 AM (0618).

The moving of the body from position 1 to position 2 (Fig. 14) left a trail of blood (Fig. 7, at 1), which came from both the entrance wound and blood flow from the victim's mouth (Fig. 9A). At bloodstain 2 (Fig. 7) is a large stain that has spines and satellite spatter. This was created when the victim's head was elevated above the pavement and his head turned left spilling blood from the vessel-like wound (Fig. 1A) before placing the body down where additional bleeding from the wound added to the blood pool, which flowed west (Fig. 8). The body was moved again to its final position (Fig. 14, BODY POSITION 3) where the blood pool 2 was joined by the blood pool 3 (Fig. 8). The demarcation of the two blood pools is estimated in Fig. 8B. The victim's heart was beating for some time after he was shot.

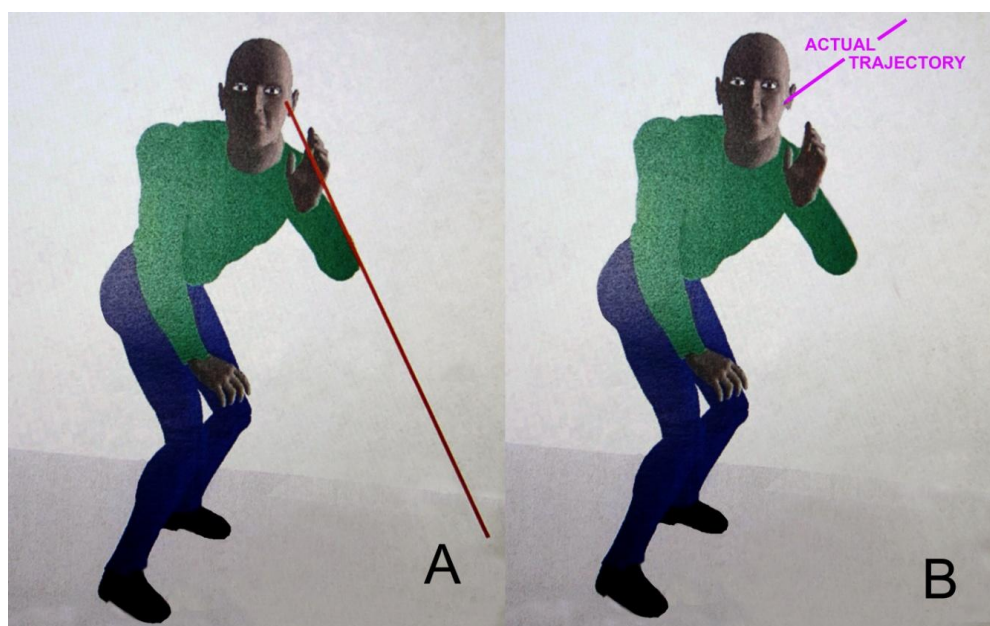
**Fig. 16.** (A) Graphic of the Billy Joe Johnson “accidental” death scenario presented to the George County Grand Jury, which showed an incorrect shot trajectory (red line). (B) The corrected graphic of the trajectory of the shot from the shotgun discharge; the shot was from left to right and upward from the mouth or in terms of shotgun discharge origin, the trajectory of the near contact discharge was downward from the left ear to the mouth. Because the shot was penetrating, there was massive blowback.

The George County Grand Jury allegedly interviewed 30 witnesses and reviewed 65 exhibits [3]. Only one of these exhibits was available for this study, which was a summary graphic presented to the jury showing an incorrect trajectory of the alleged accidental discharge of the shotgun (Fig. 16A). The correct angle is shown in Fig. 16B.
